*Suspect Chinese Drywall Analysis
Copper Coupon Corrosion Test*

<i>Inspector:</i>	<i>A. Inspector</i>	<i>Collected:</i>	<i>9/19/2010</i>
<i>Project:</i>	<i>J. Doe</i>	<i>Received:</i>	<i>9/20/2010</i>
<i>Job #:</i>		<i>Reported:</i>	<i>9/27/2010</i>
<i>ABID:</i>	<i>AI092010-1</i>	<i>Analyst:</i>	<i>M. Dinse</i>

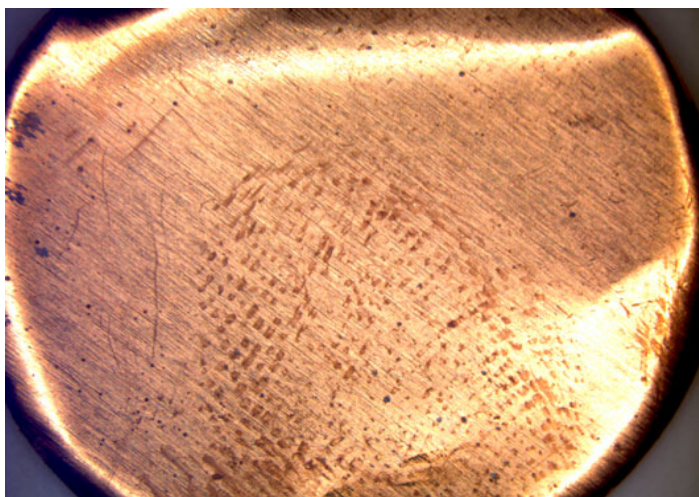
Sample ID: Master Bath

Results: **Non-Corrosive** The corrosion characteristics of the copper coupon exposed to the submitted sample drywall is inconsistent with corrosion that occurs on a copper token exposed to Chinese drywall reference materials, including the lack of a characteristic greyish-black patina on the copper surface.

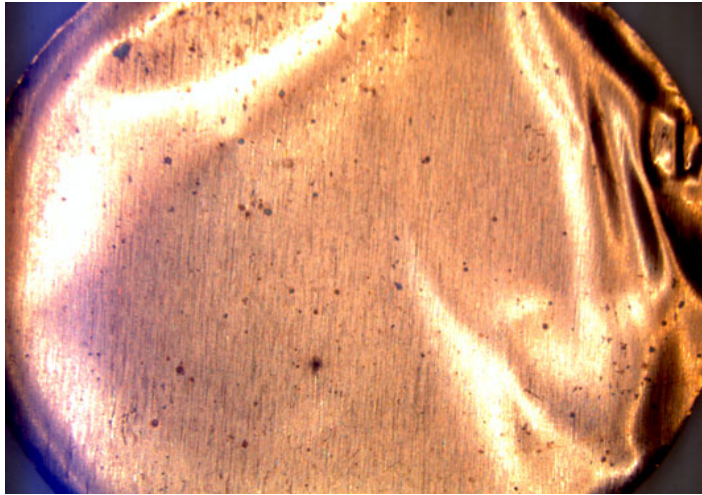
Sample ID: Master Bedroom

Results: **Non-Corrosive** The corrosion characteristics of the copper coupon exposed to the submitted sample drywall is inconsistent with corrosion that occurs on a copper token exposed to Chinese drywall reference materials, including the lack of a characteristic greyish-black patina on the copper surface.

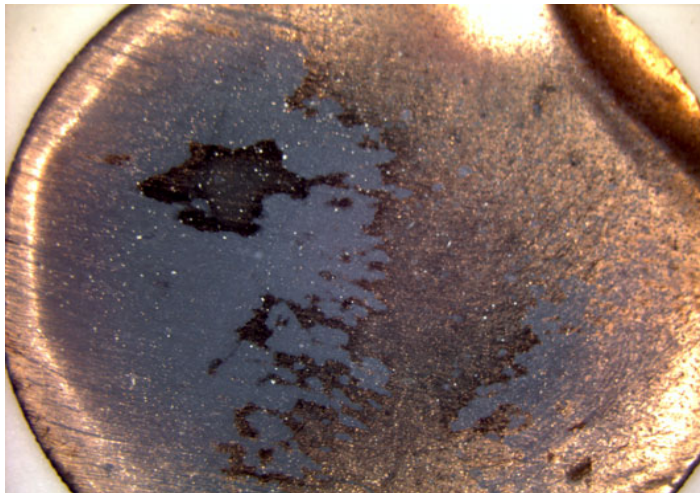
Sample ID: Kitchen

Results: **Corrosive**

The corrosion characteristics of the sample drywall is consistent with corrosion that occurs on a copper token exposed to Chinese drywall reference materials, including the formation of a greyish-black patina on the copper surface.

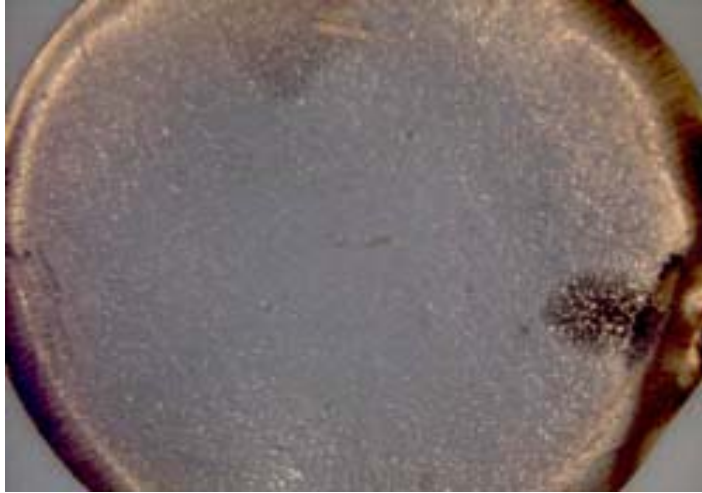
Sample Number: AB-POS
Sample ID: Positive Control Coupon exposed to Corrosive Drywall

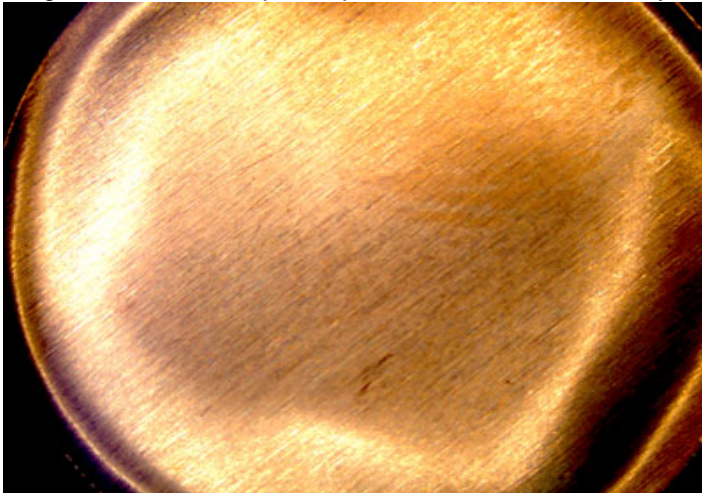
Sample Number: AB-NEG
Sample ID: Negative Control Coupon exposed to Non-Corrosive Drywall
