Suspect Chinese Drywall Analysis Copper Coupon Corrosion Test

Inspector:	Joe Sampler	Collected:	11/25/2013
Project:	105 Method Road	Received:	11/26/2013
Job #:	456JRR	Reported:	12/4/2013
ABID:	JS112613-13	Analyst:	Laboratory Analyst

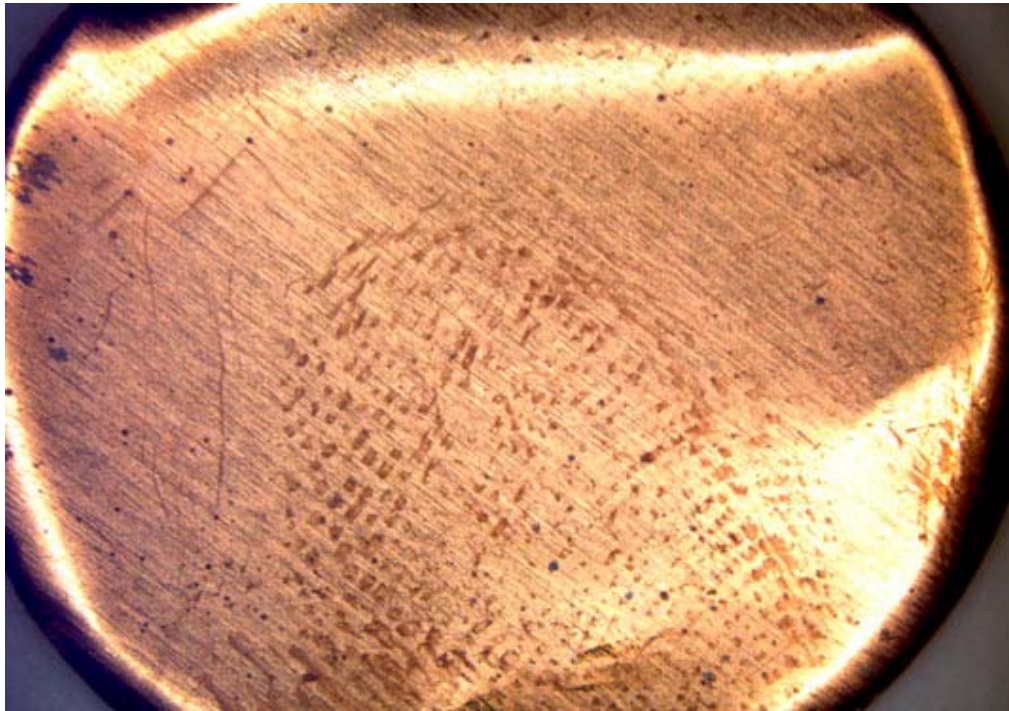
Sample Number: JS112613-13-1
Sample ID: Master Bedroom

Results: **Non-Corrosive** The corrosion characteristics of the copper coupon exposed to the submitted sample drywall is inconsistent with corrosion that occurs on a copper token exposed to Chinese drywall reference materials, including the lack of a characteristic grayish-black patina on the copper surface.

Figure. Stereomicrograph of a copper token exposed to the submitted drywall sample.

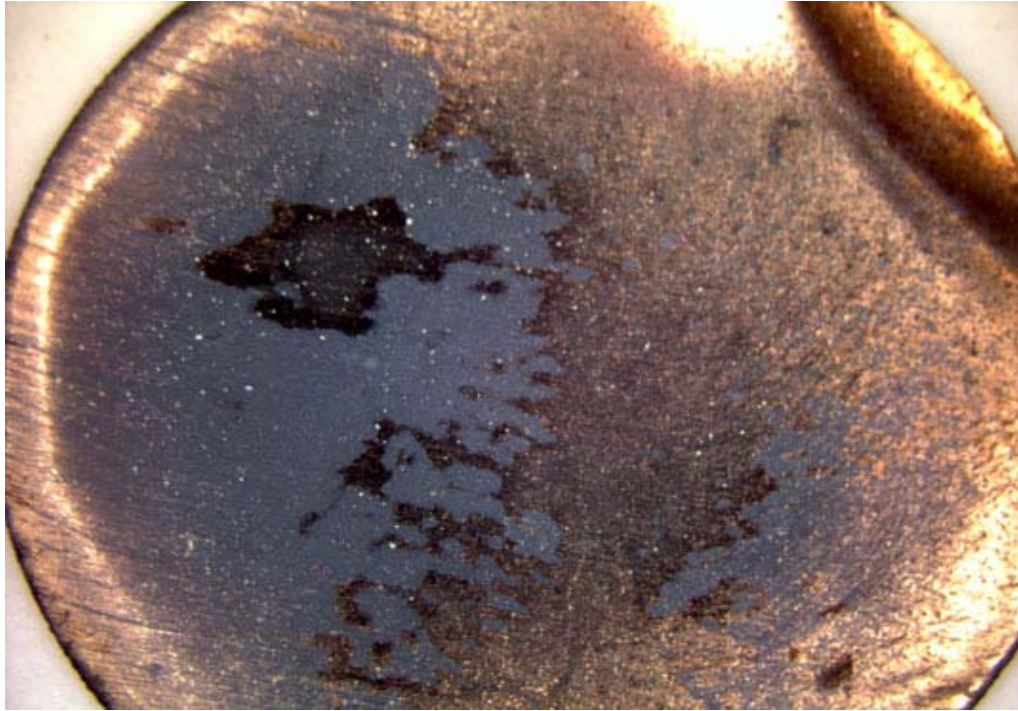
Sample Number: JS112613-13-2

Results: **Corrosive**

The corrosion characteristics of the sample drywall is consistent with corrosion that occurs on a copper token exposed to Chinese drywall reference materials, including the formation of a grayish-black patina on the copper surface.

Figure. Stereomicrograph of a copper token exposed to the submitted drywall sample.
