Suspect Chinese Drywall Analysis Copper Coupon Corrosion Test

| Project: | A. House | Received: | 10/2/2009 |
| ABID: | AI1000209-1 | Analyst: | M. Dinse |

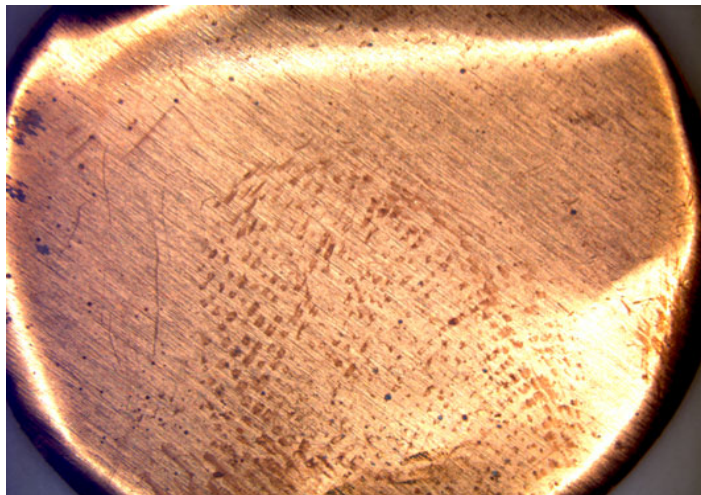
Non-Corrosive The corrosion characteristics of the copper coupon exposed to the submitted sample drywall is inconsistent with corrosion that occurs on a copper token exposed to Chinese drywall reference materials, including the lack of a characteristic greyish-black patina on the copper surface.

Figure. Stereomicrograph of a copper token exposed to the submitted drywall sample.

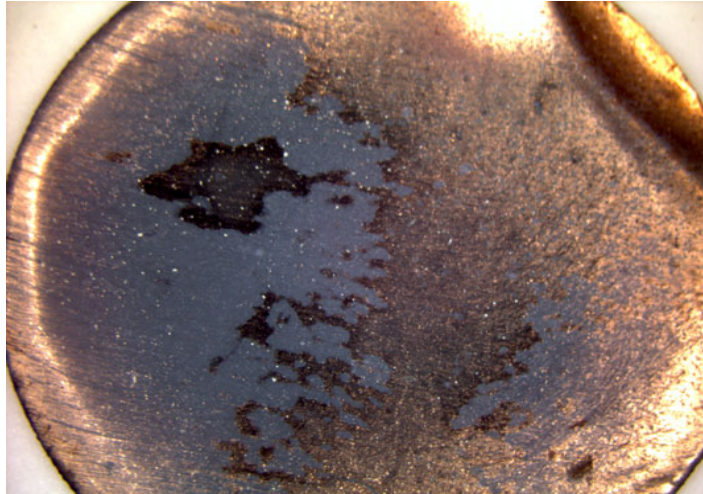
Corrosive

The corrosion characteristics of the sample drywall is consistent with corrosion that occurs on a copper token exposed to Chinese drywall reference materials, including the formation of a greyish-black patina on the copper surface.

Figure. Stereomicrograph of a copper token exposed to the submitted drywall sample.
