Introduction to Residential Mold Assessment

Assured Bio Labs, LLC

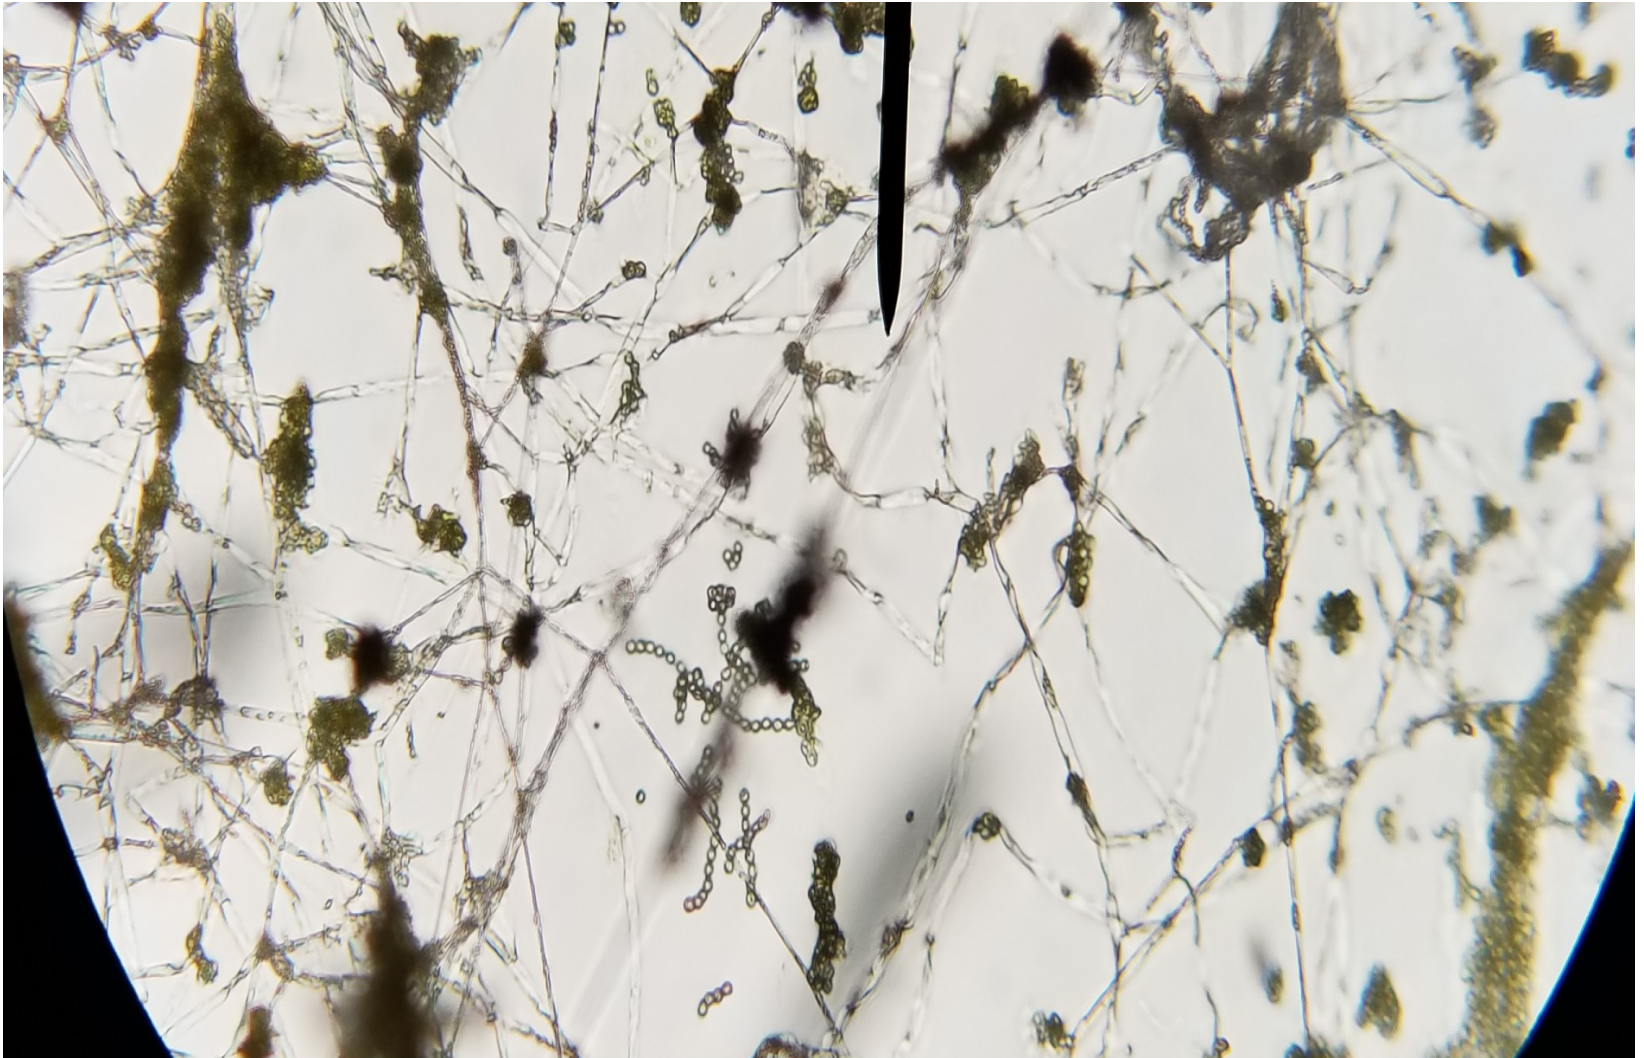
Hyphae- Branching filaments that make up the mycelium of a fungus.

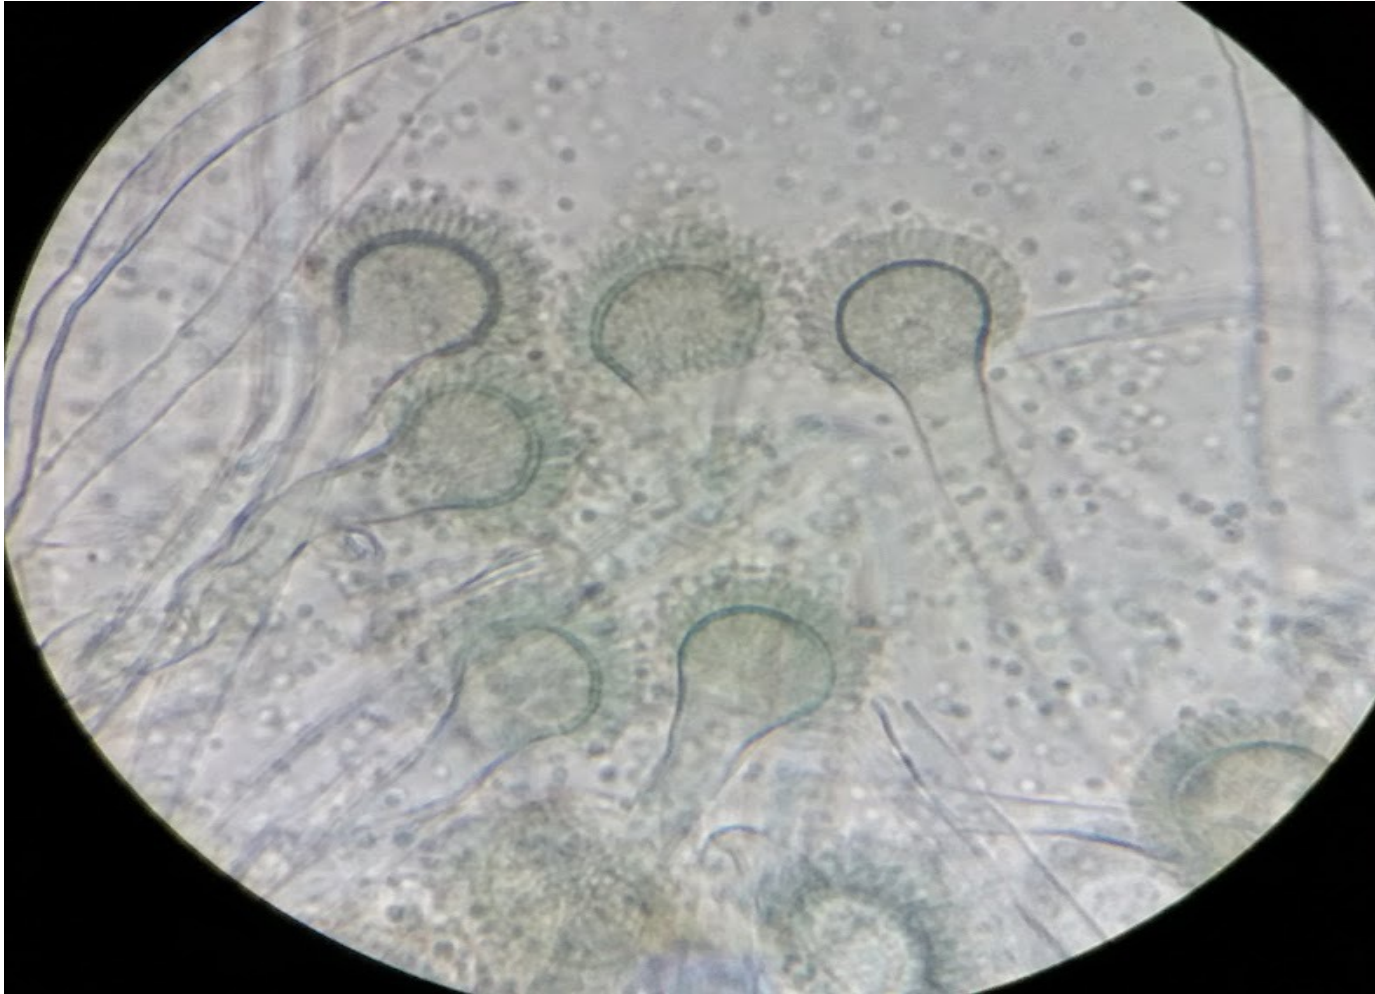
Conidiophore- A hyphal fragment associated with certain fungi.

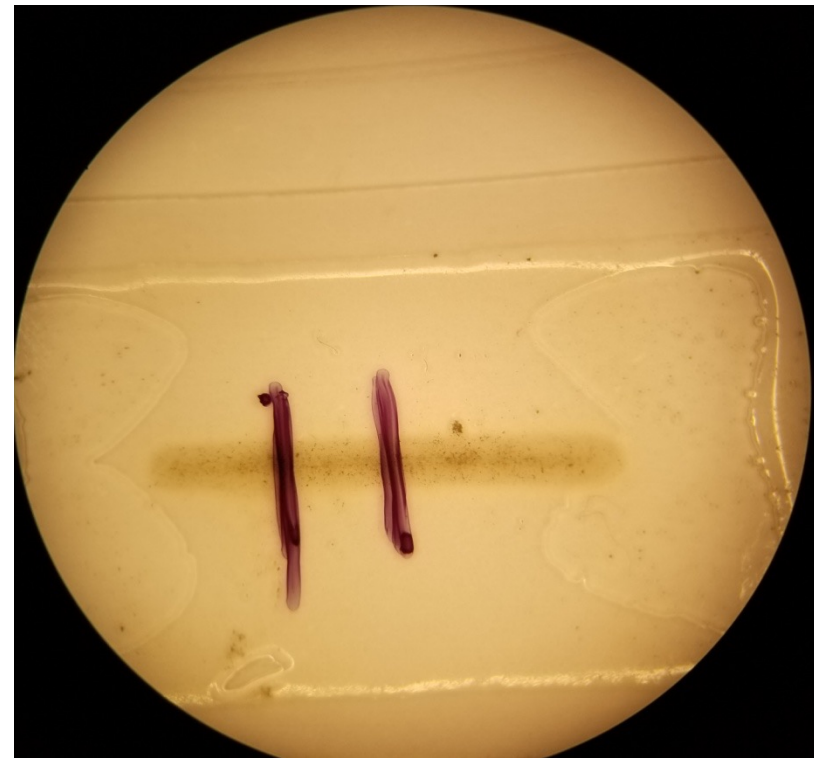
15 Liter Air-O-Cell & Allergenco

- 112 Fields of View per Sample Trace
- $\frac{1}{4}$ of the Trace (28 Fields of View) is analyzed. This number is then multiplied by 4

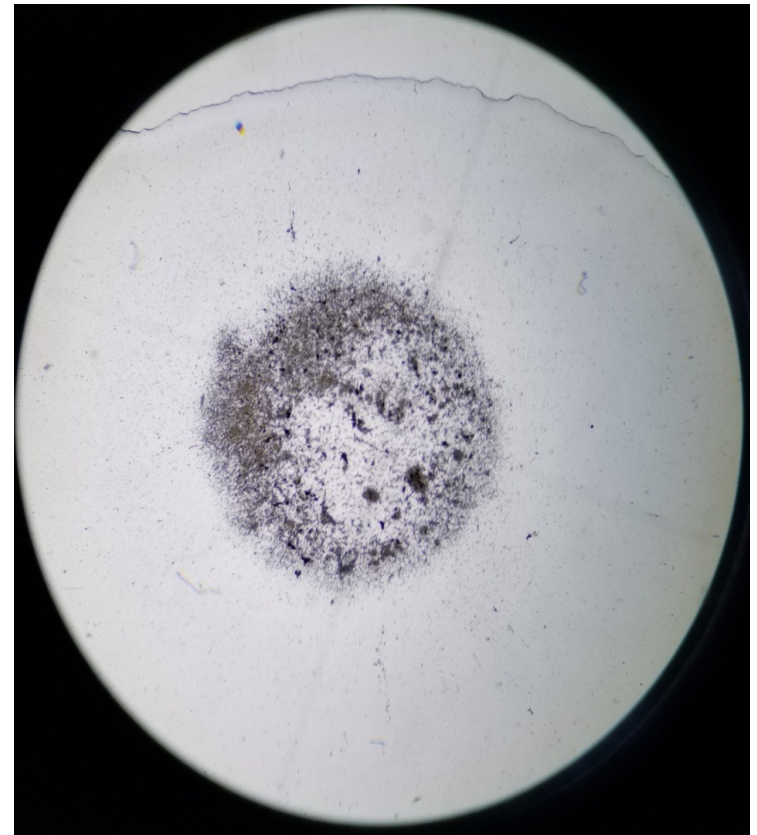
Micro 5, MoldSnap & Z5

- 28 Fields of View Per Sample Trace
- The Entire Trace is Analyzed

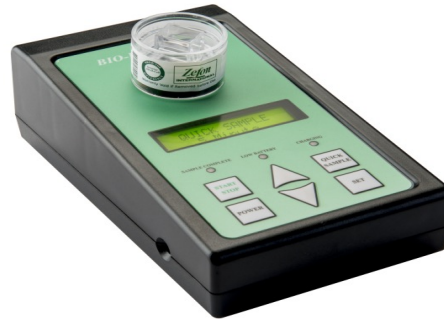
Zefon Bio-Pump

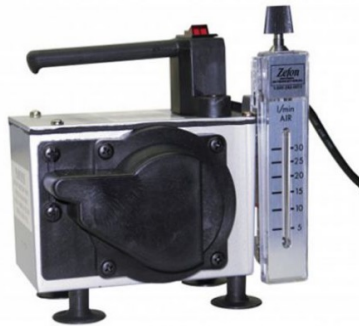
Zefon Z-Lite-IAQ

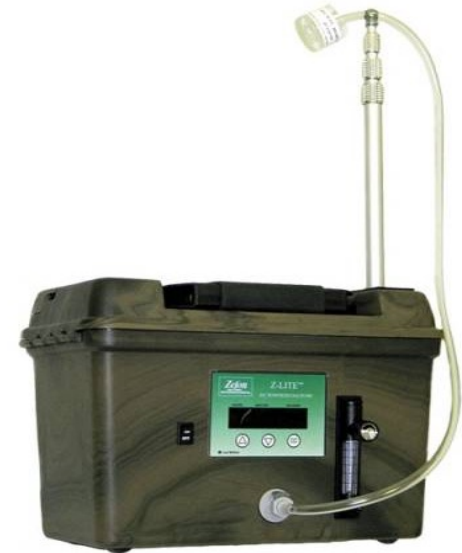
Zefon Z-Lite-IAQ-DC

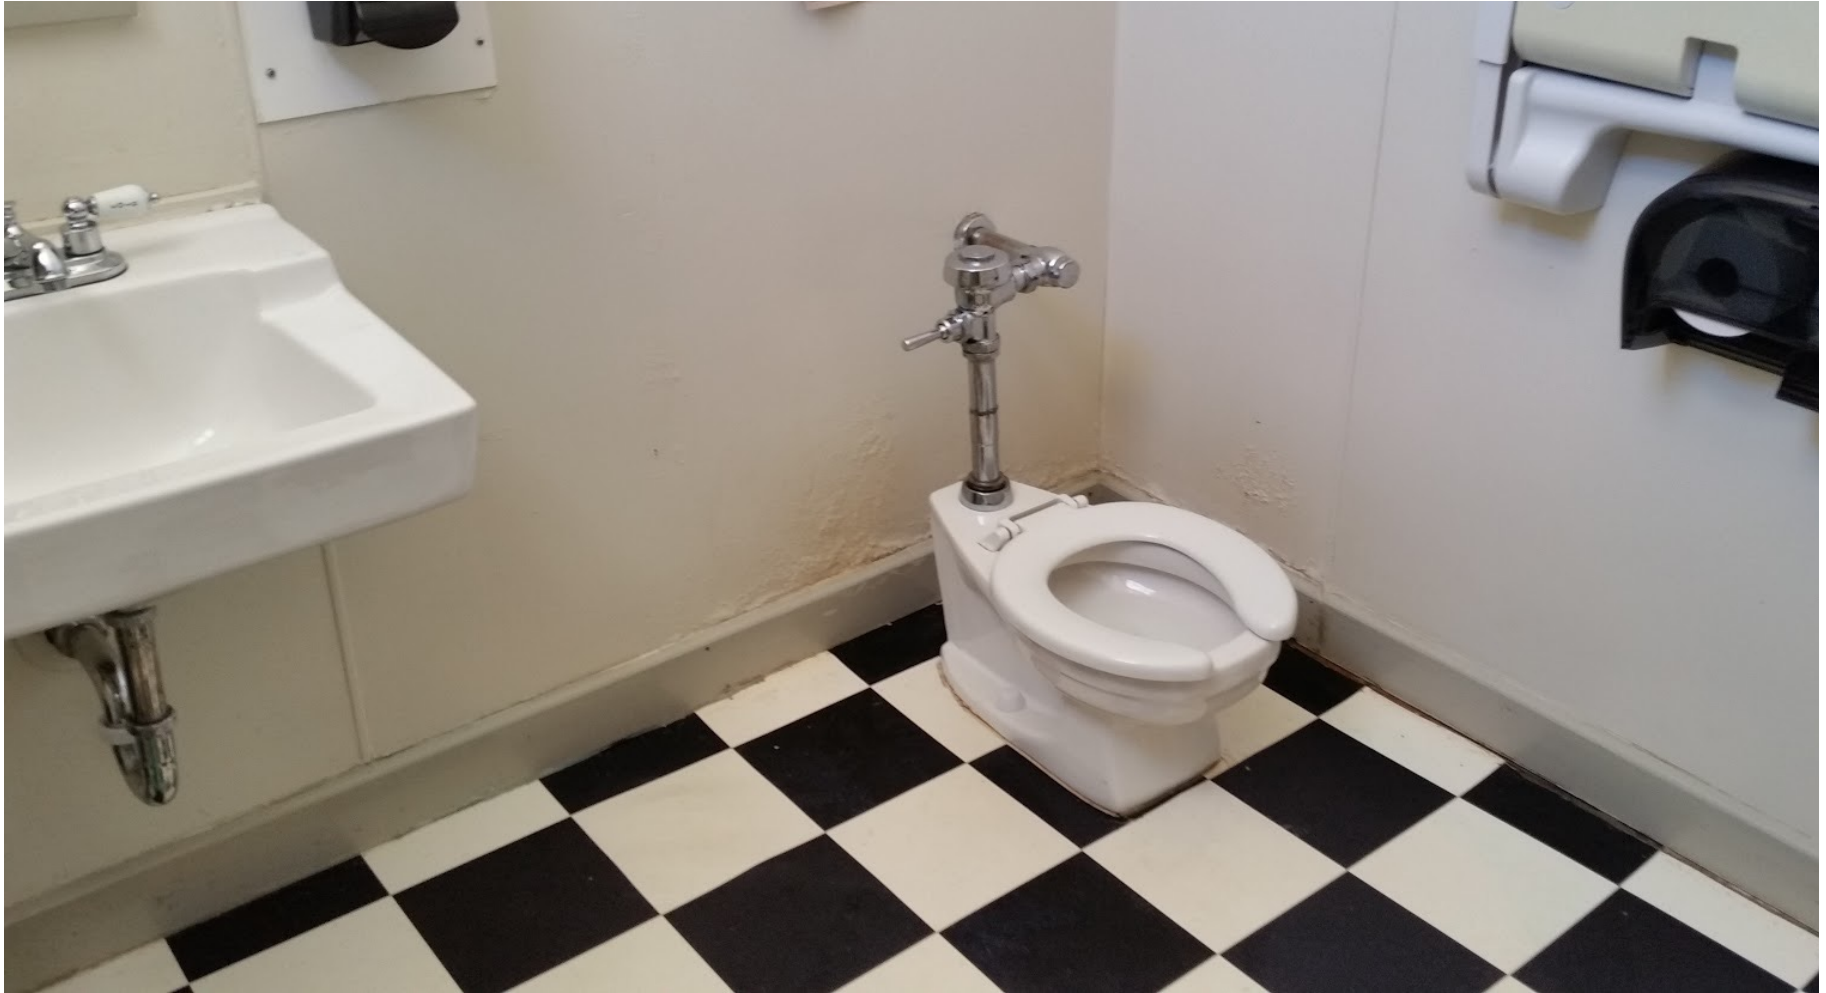
Failed Solder Joint Inside a Wall

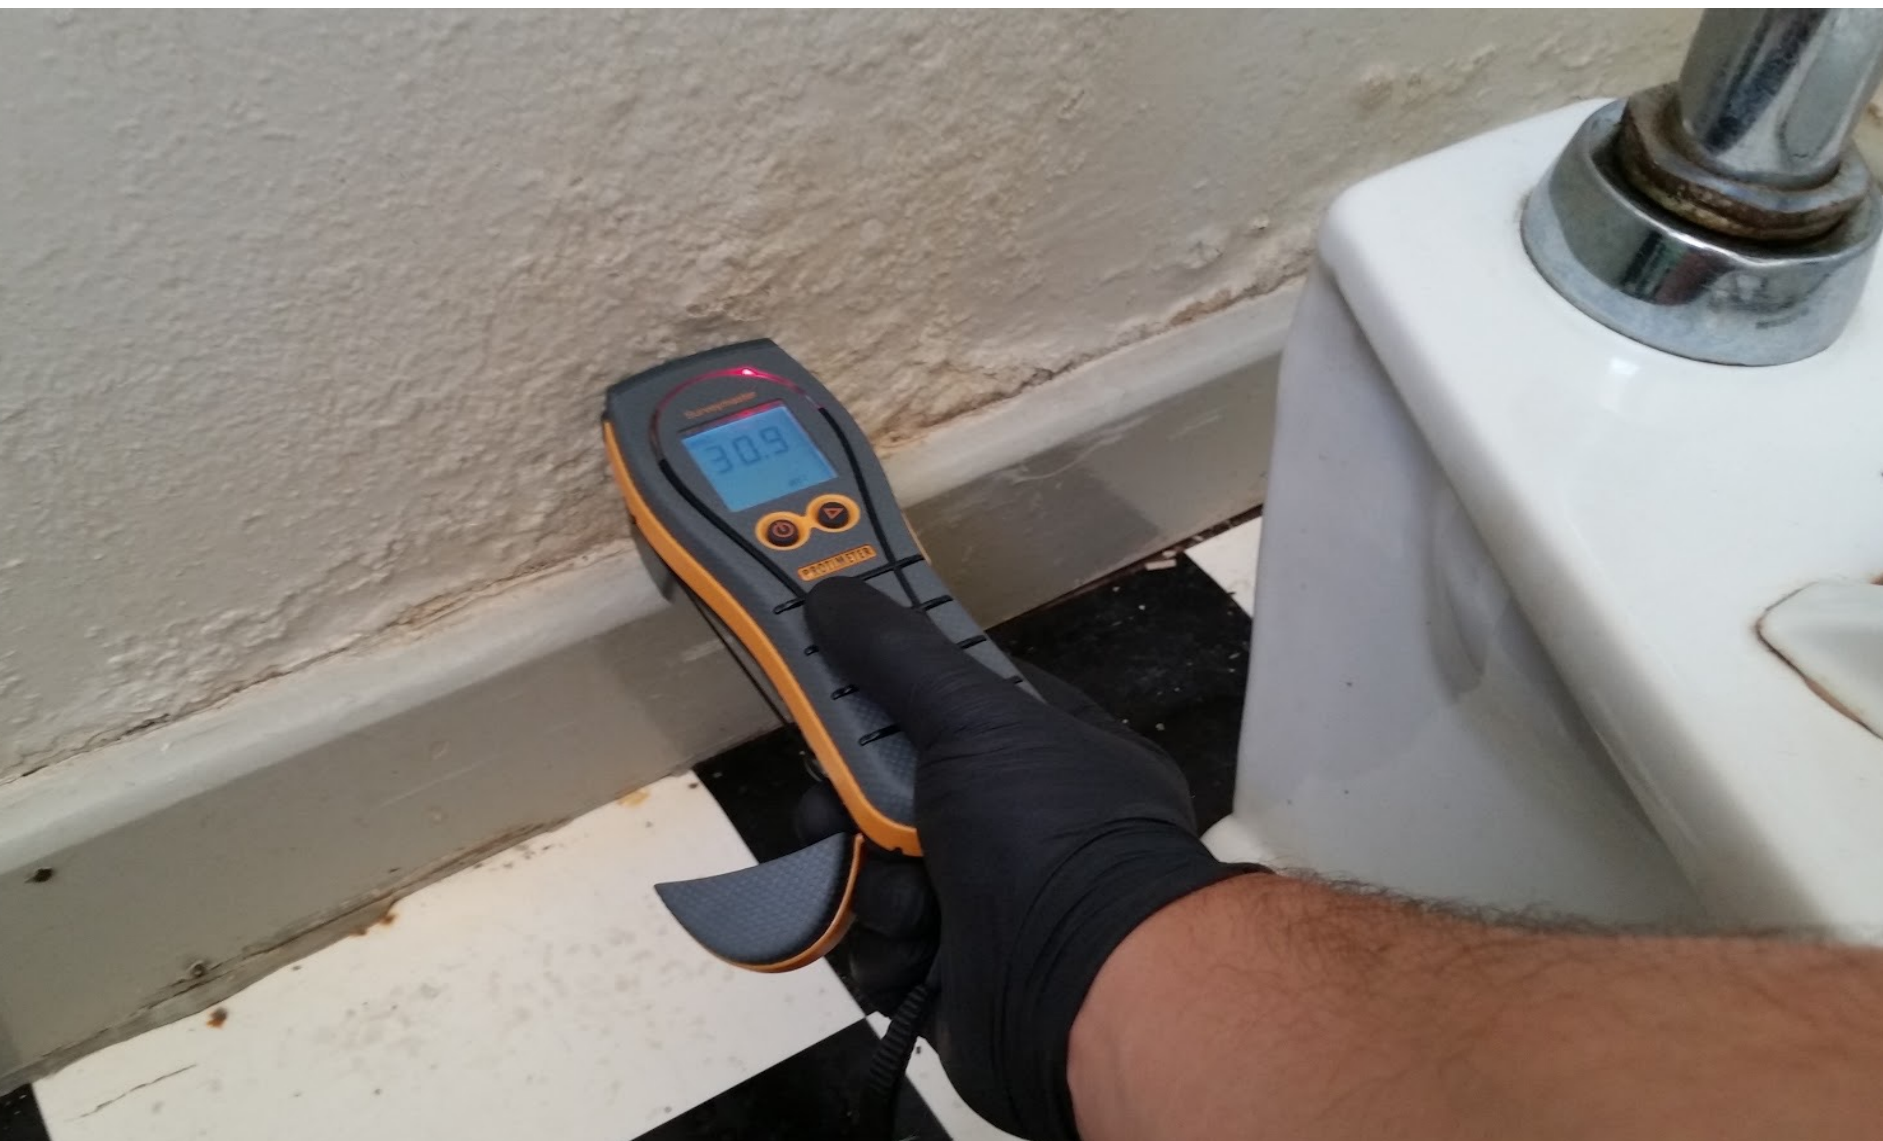
Elevated Moisture Content

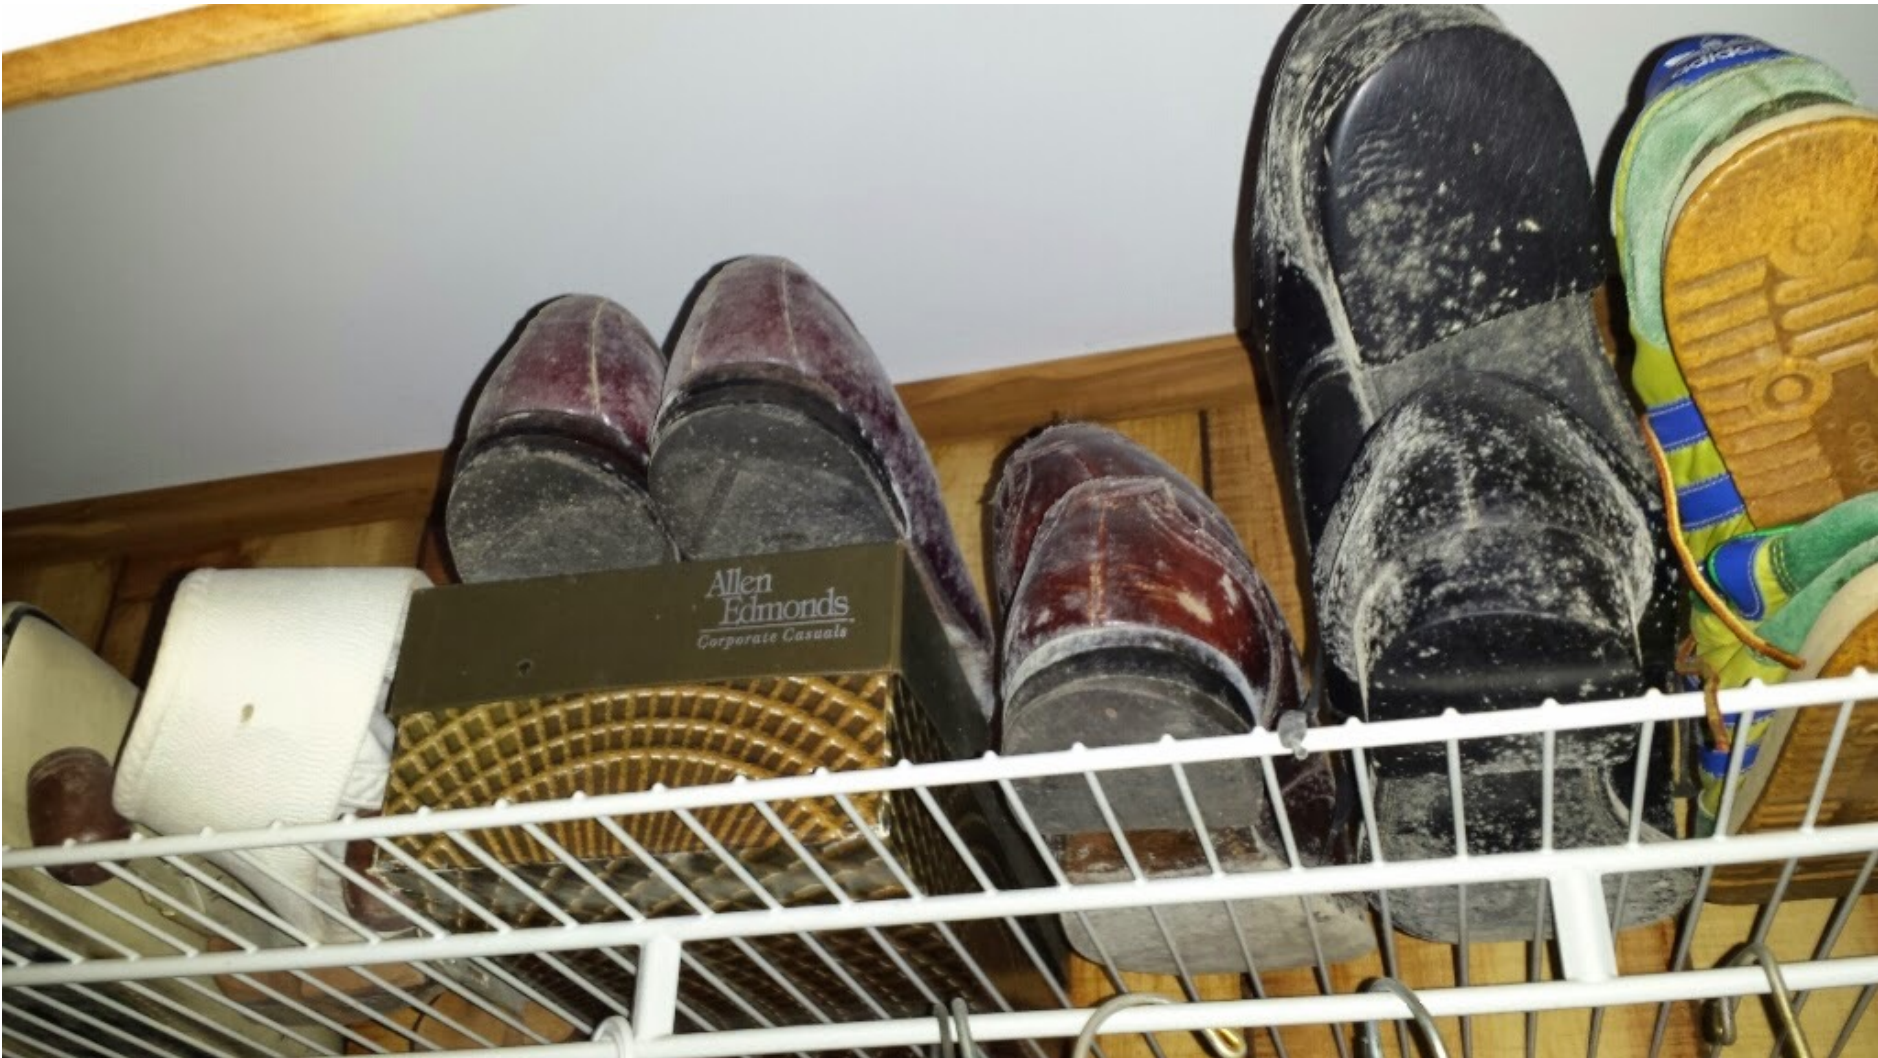
Humidity Related Surface Mold

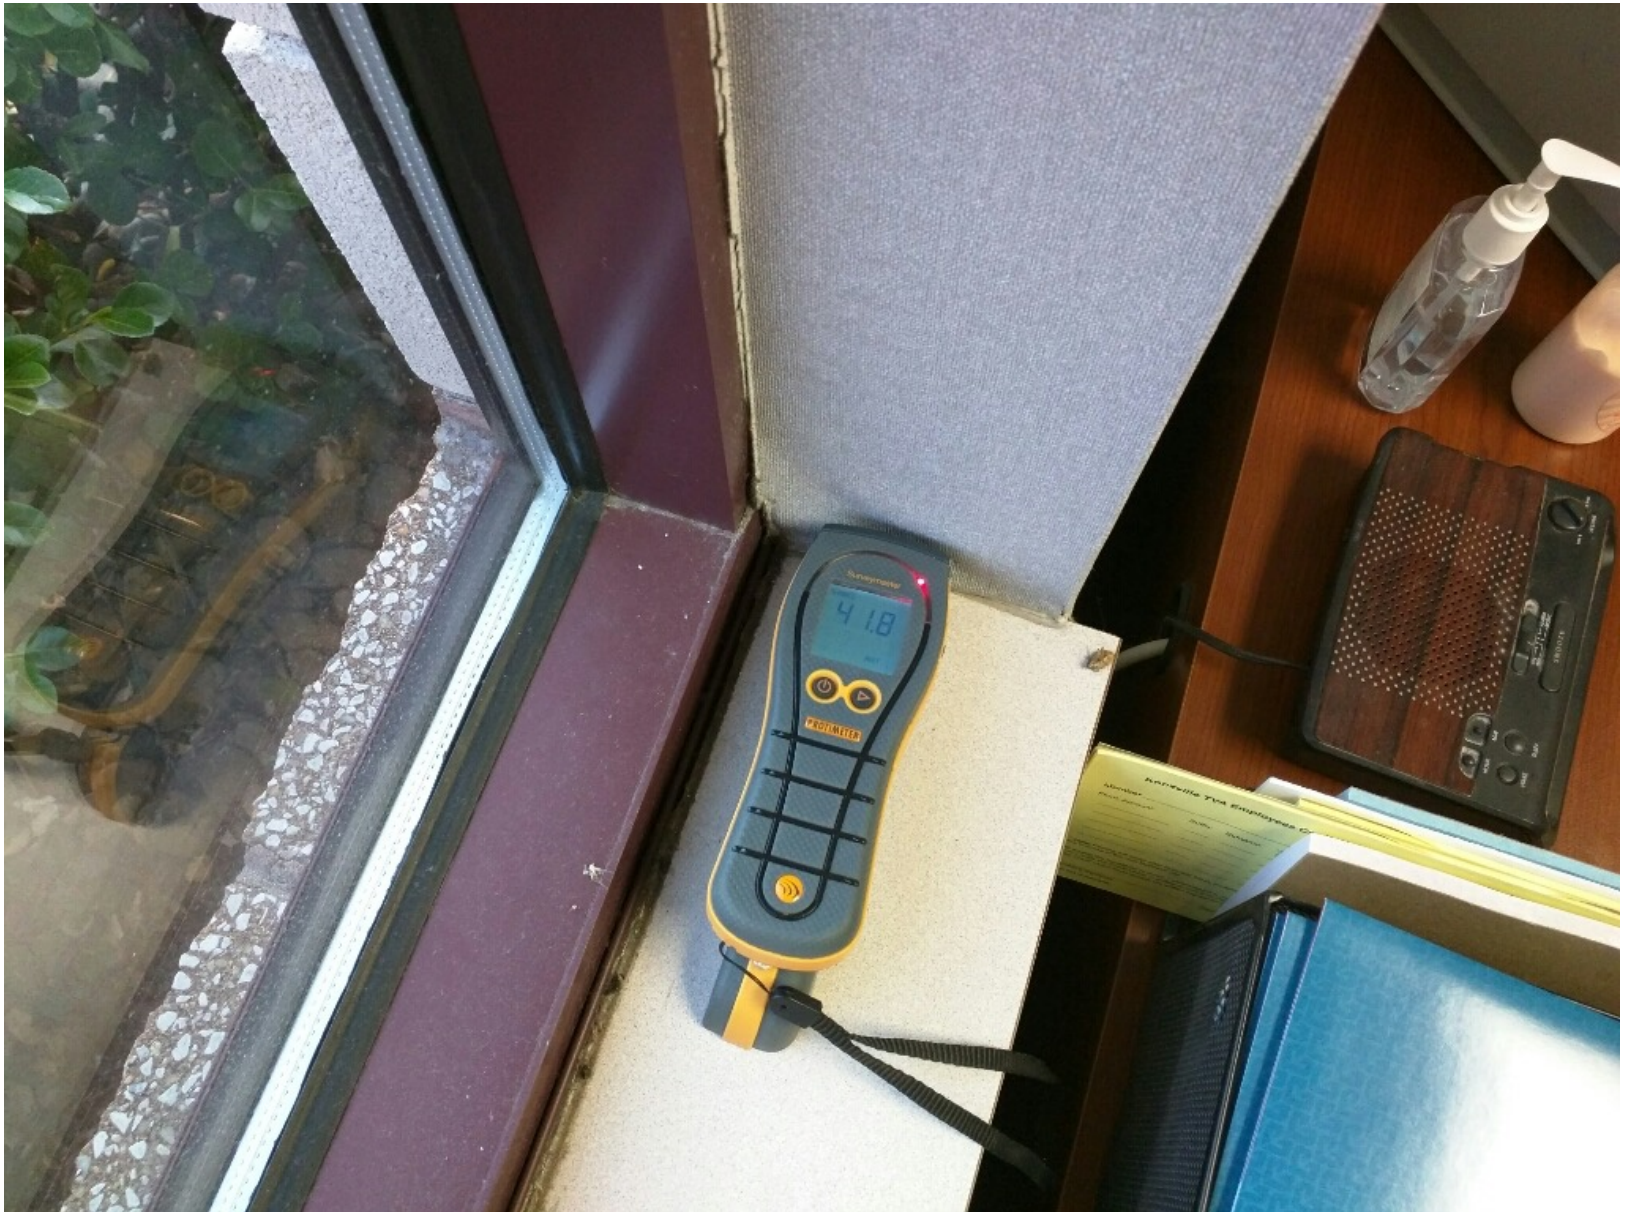
Window Leaks

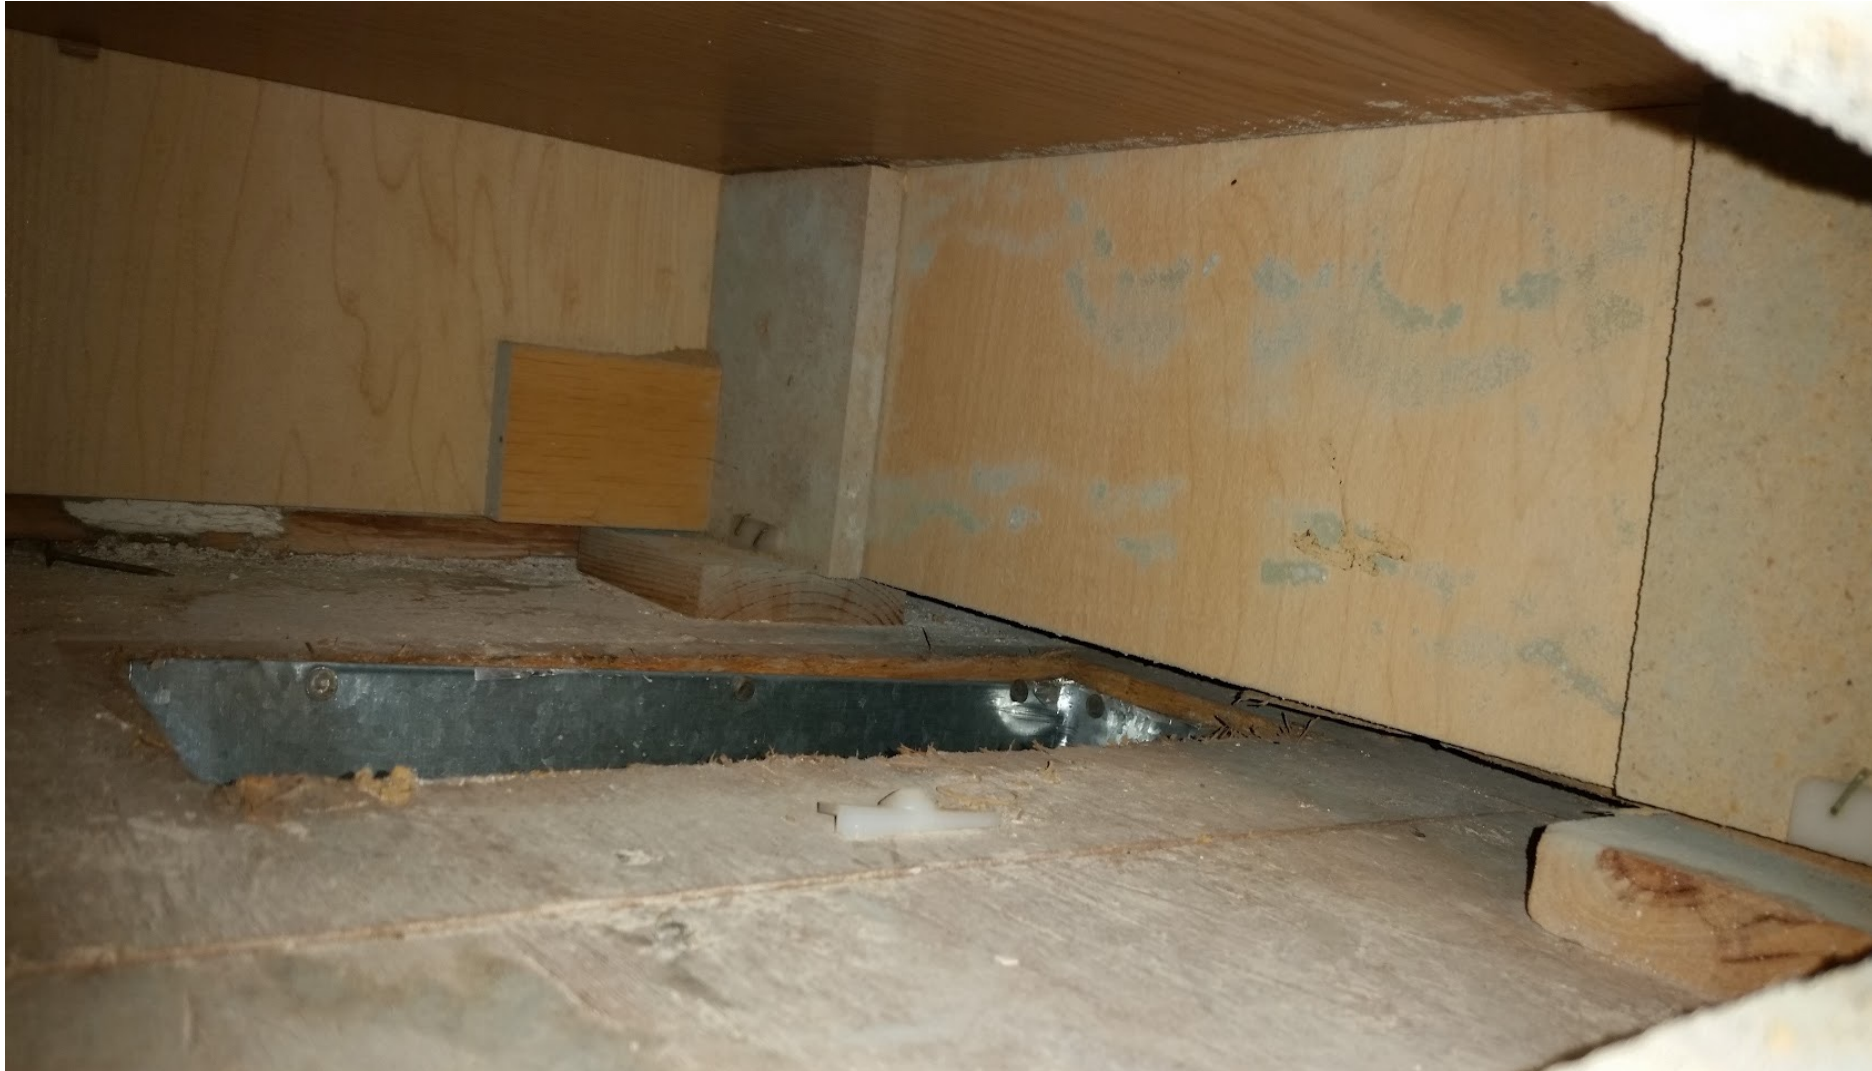
Toe Kick Plenum Interior

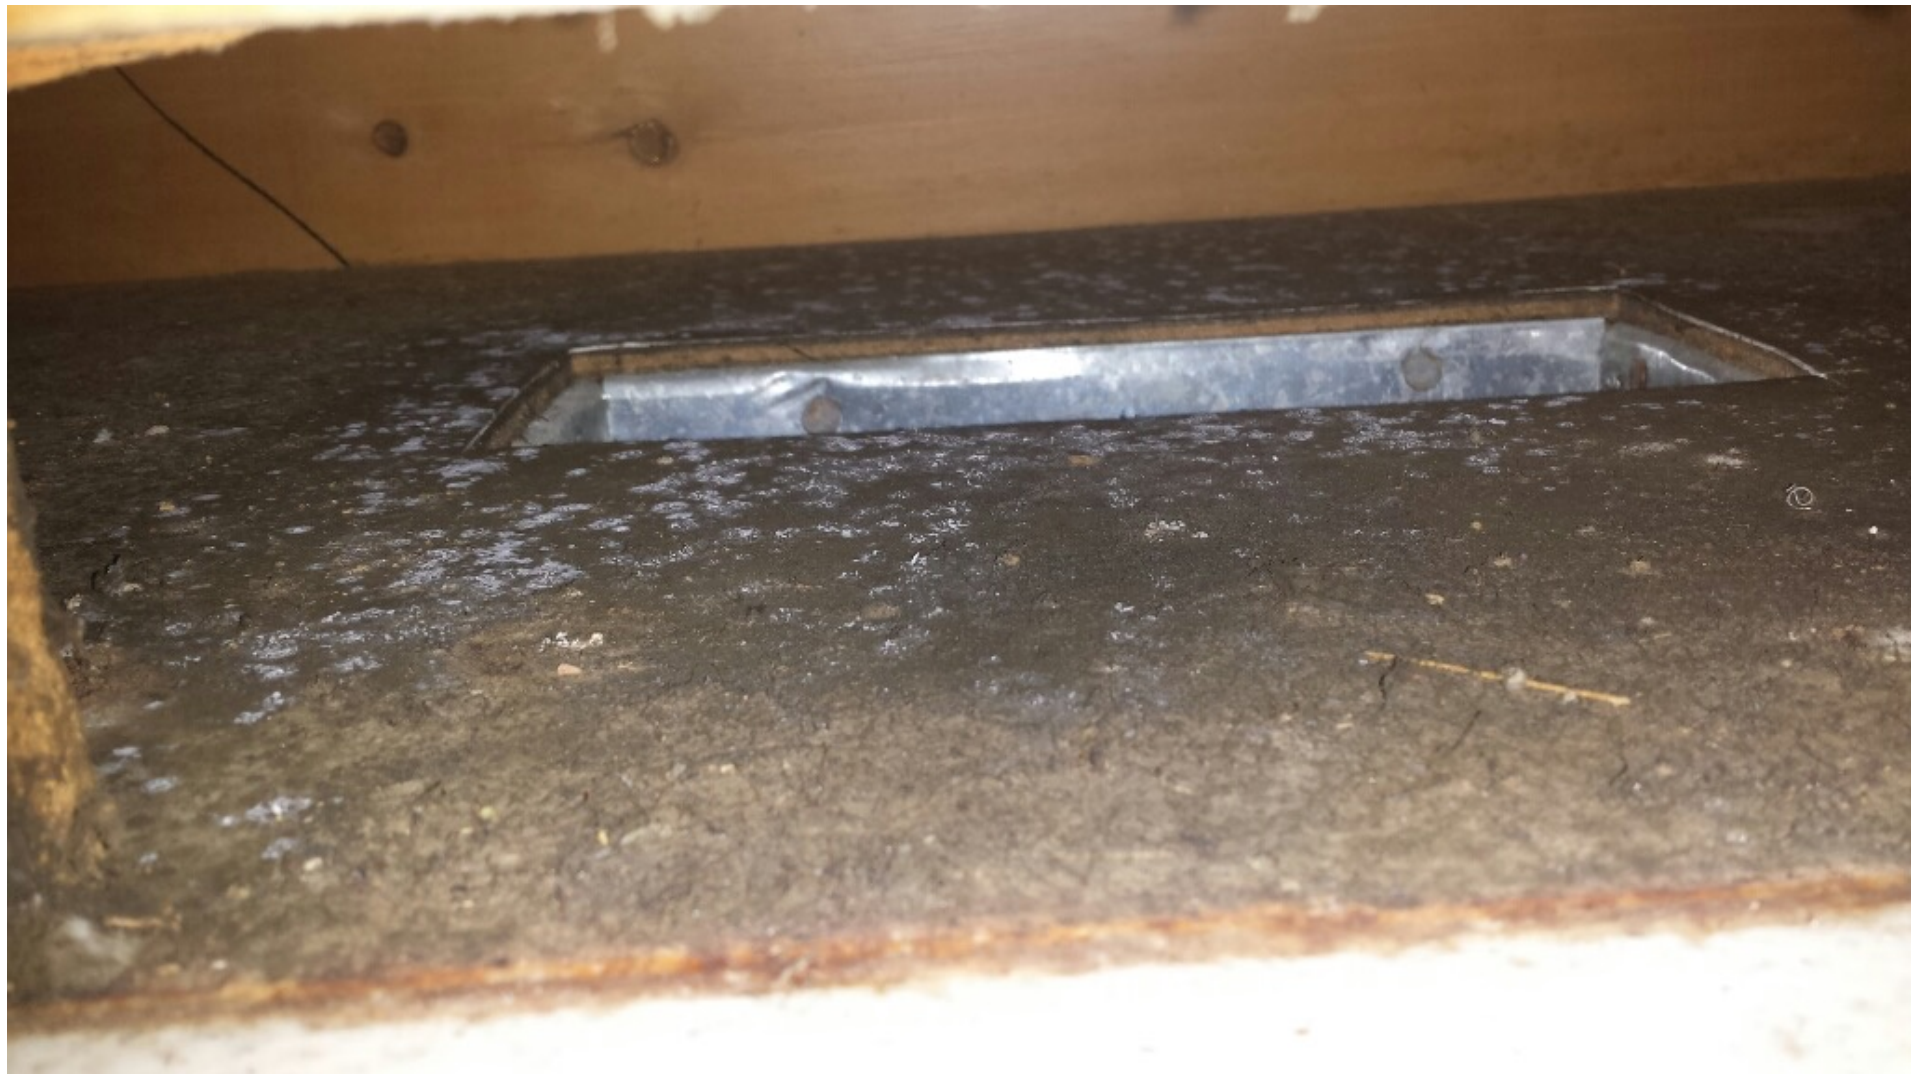
Toe Kick Plenum Interior

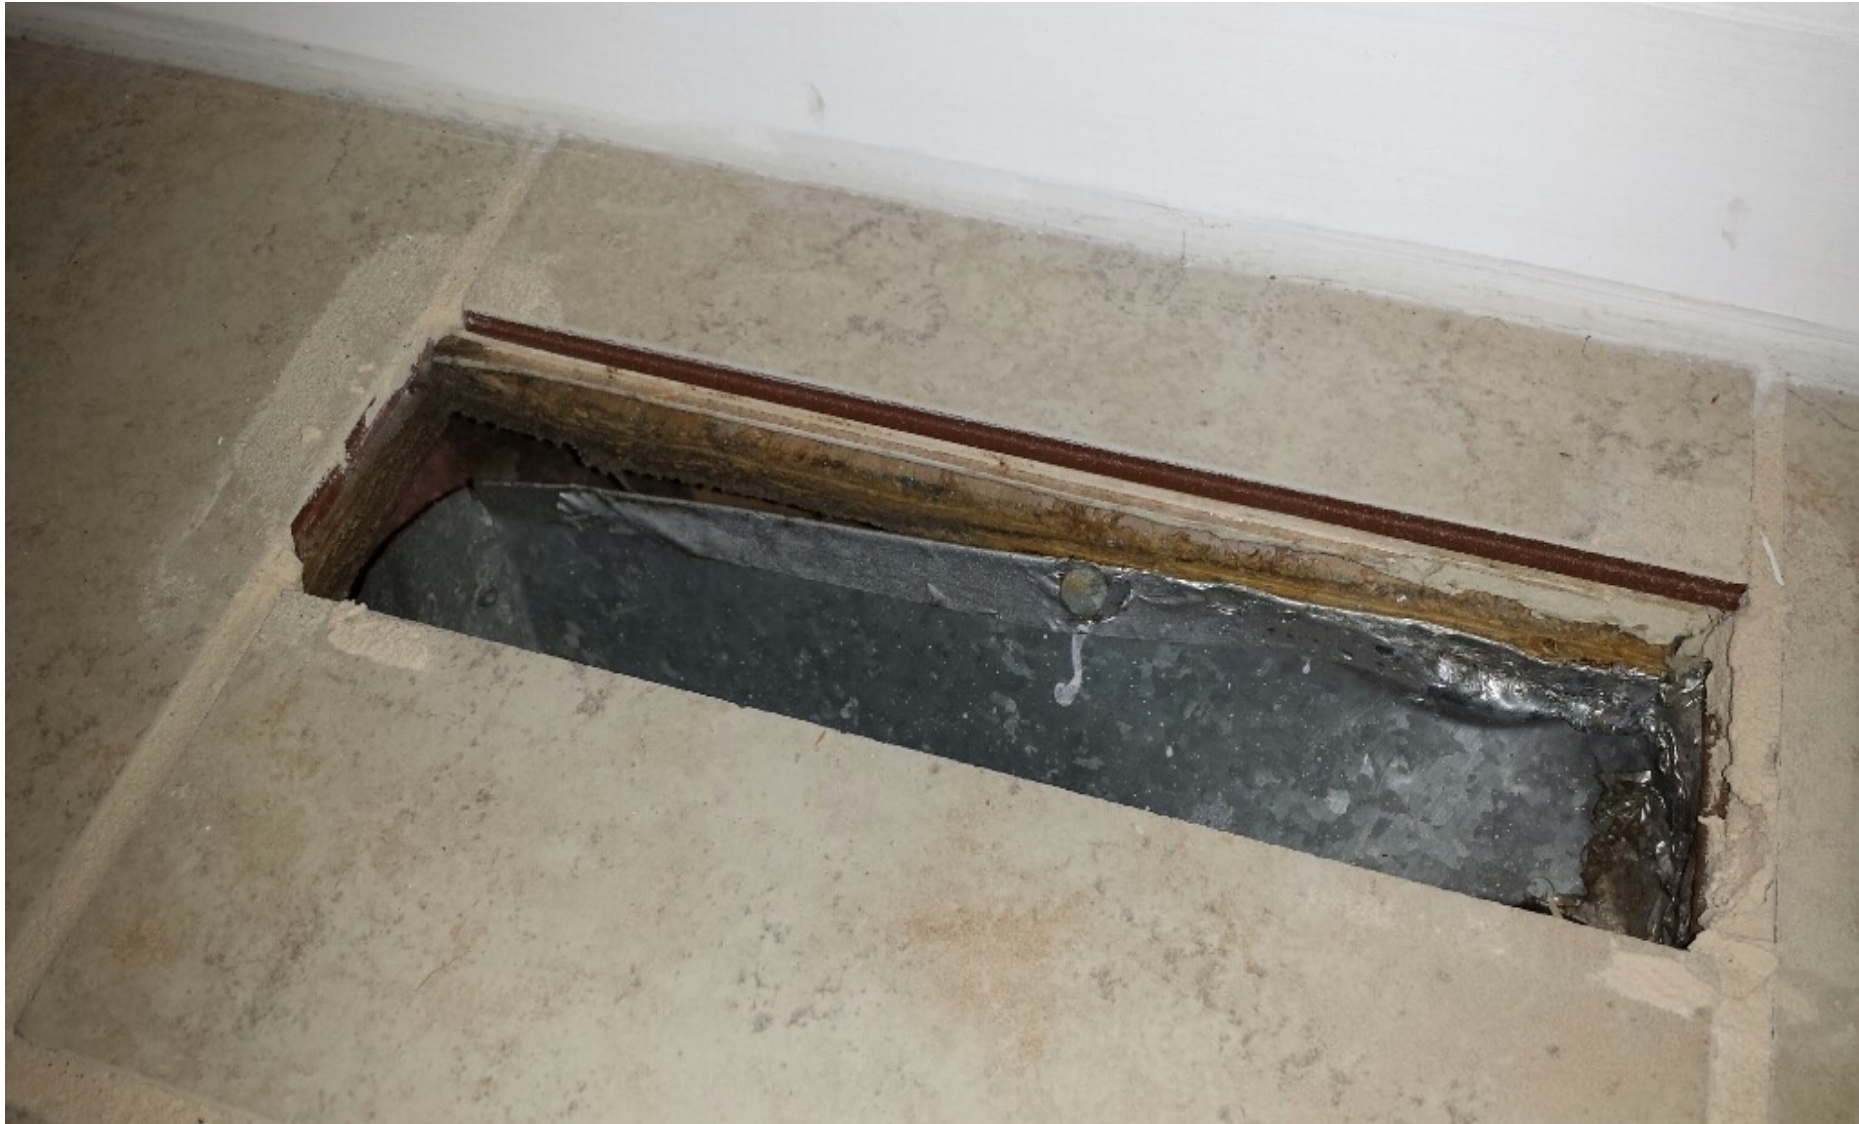
Vent Boot Penetration to Crawlspace

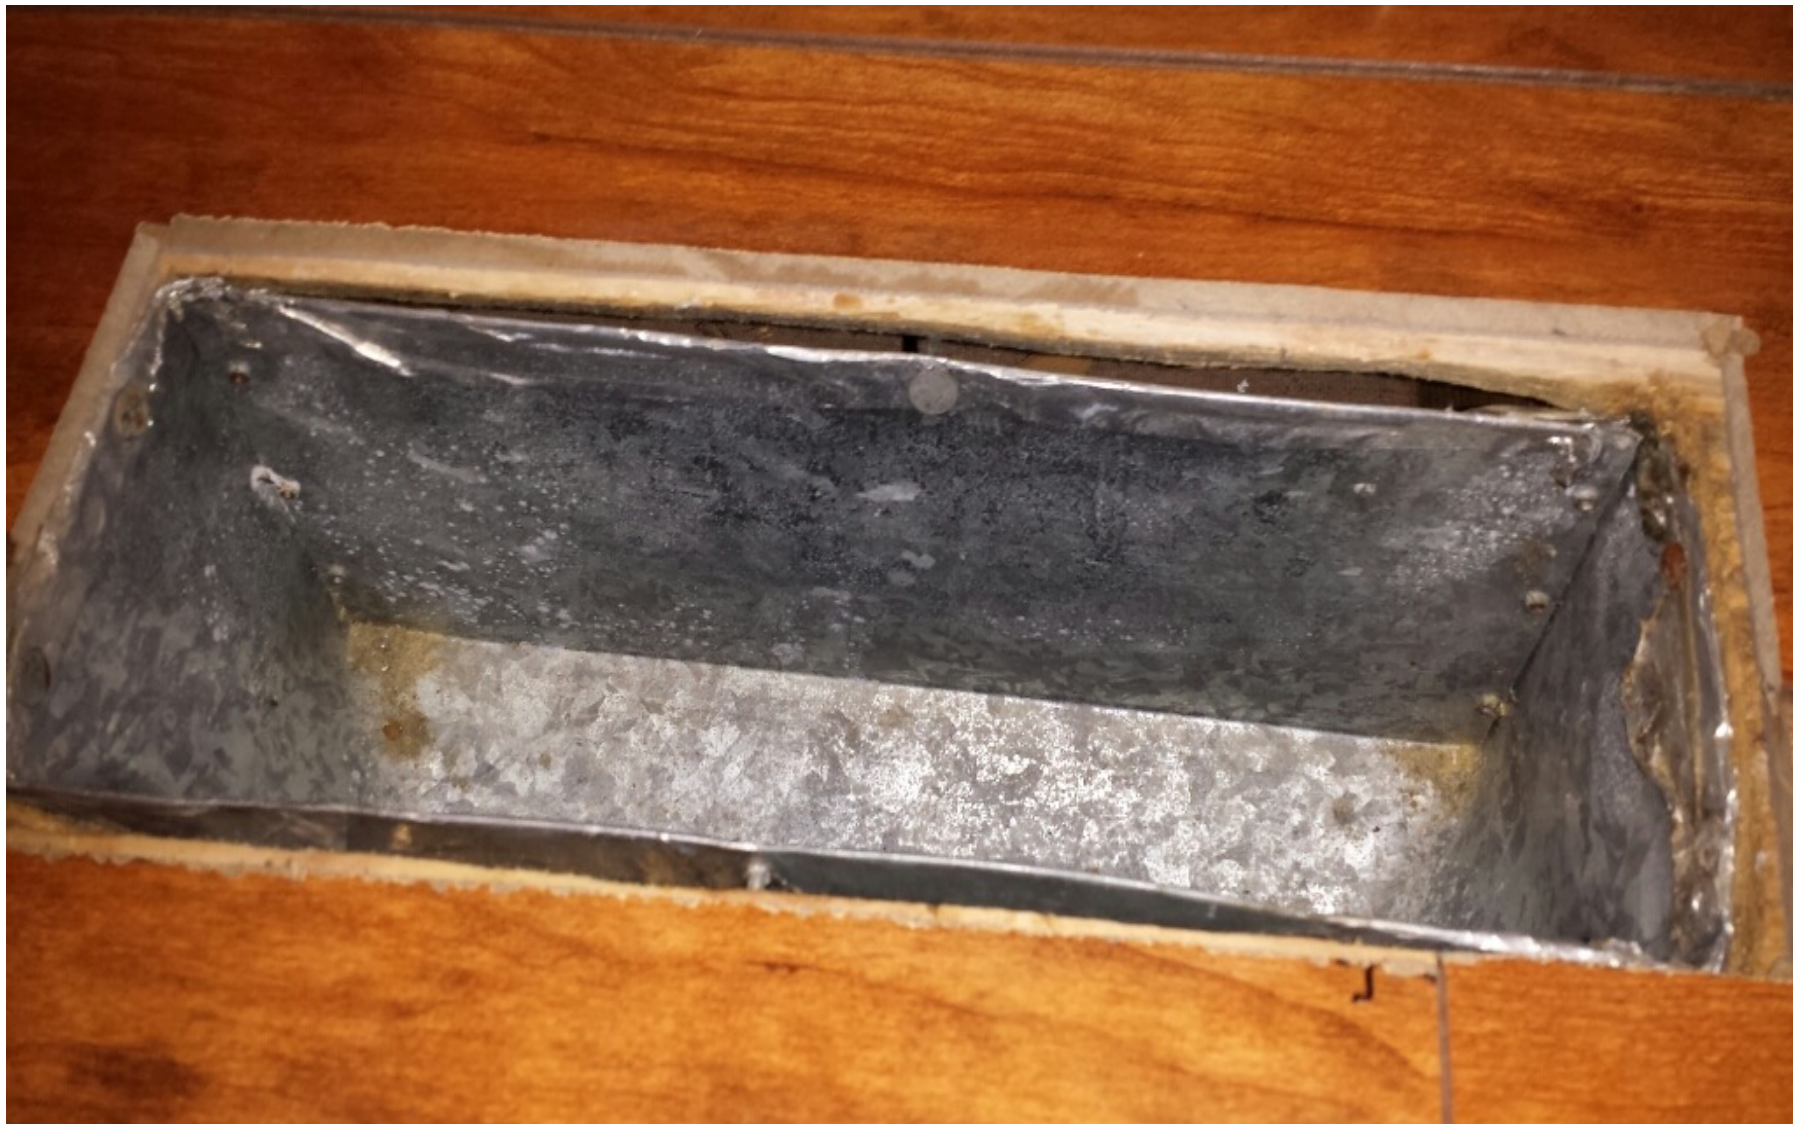
Vent Boot Penetration to Crawlspace

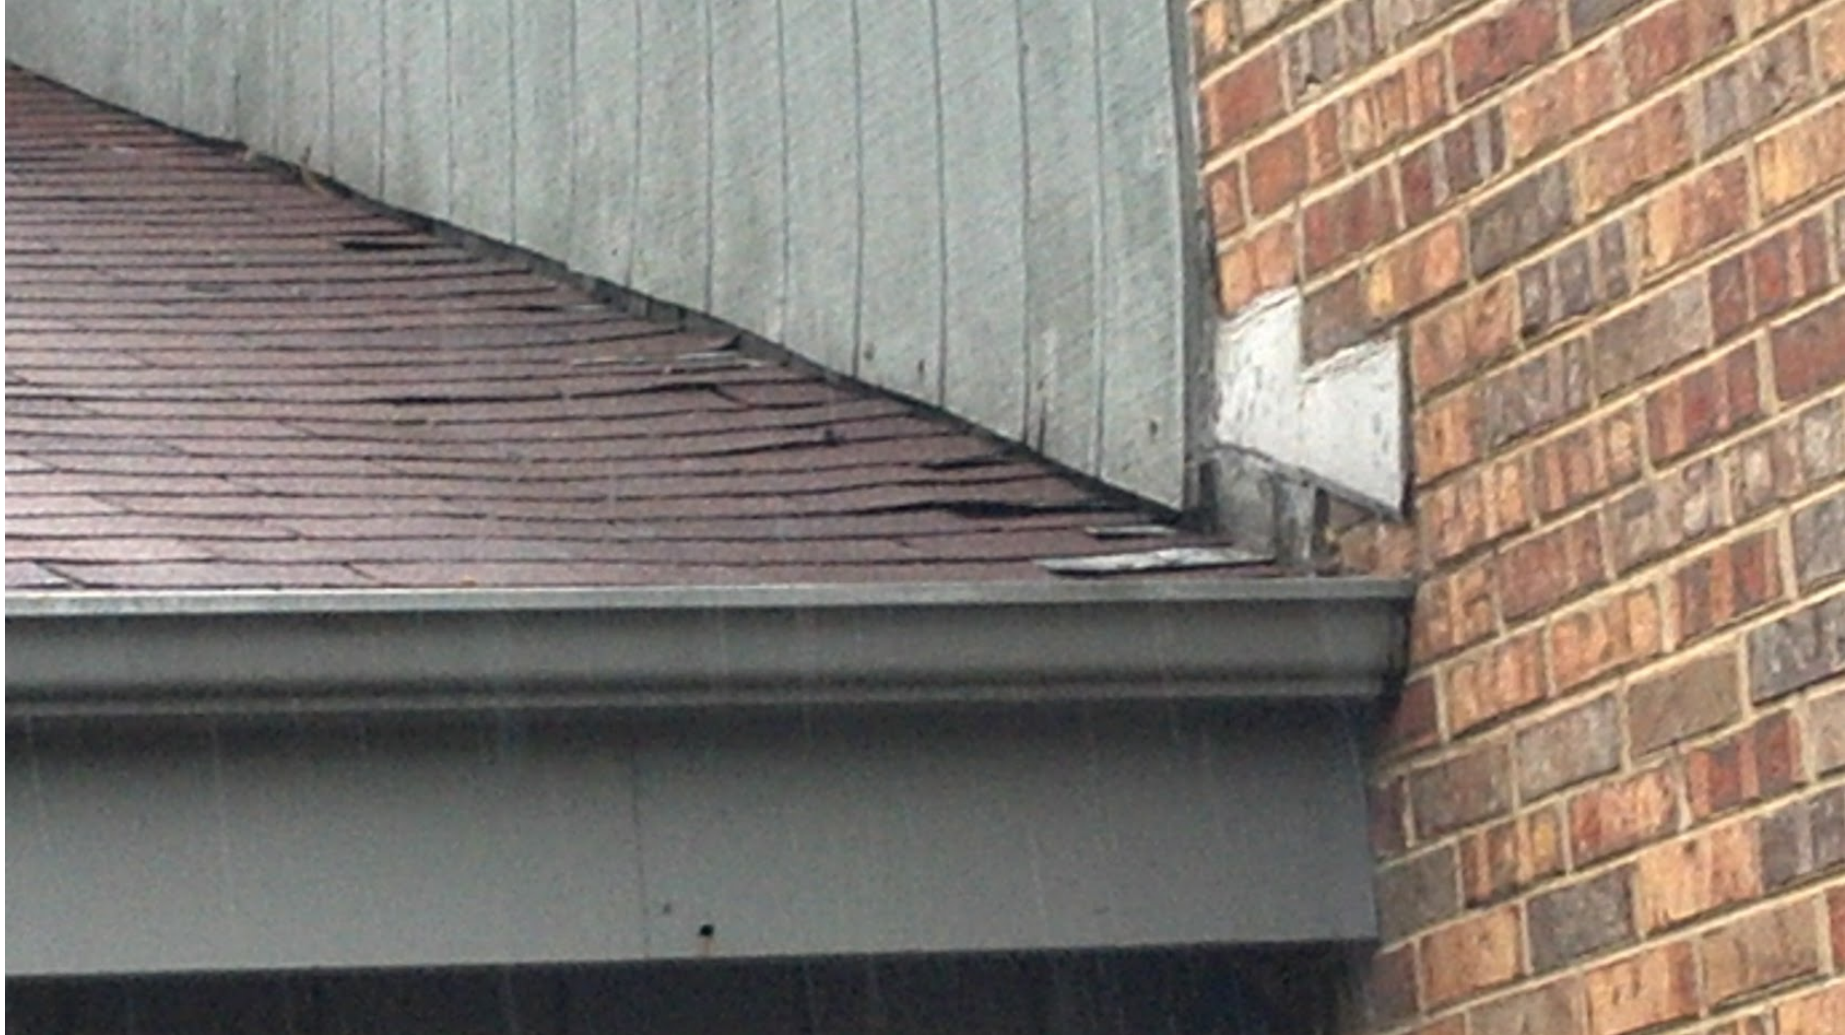
Compromised Shingles
