Introduction to Residential Mold Assessment

Assured Bio Labs, LLC

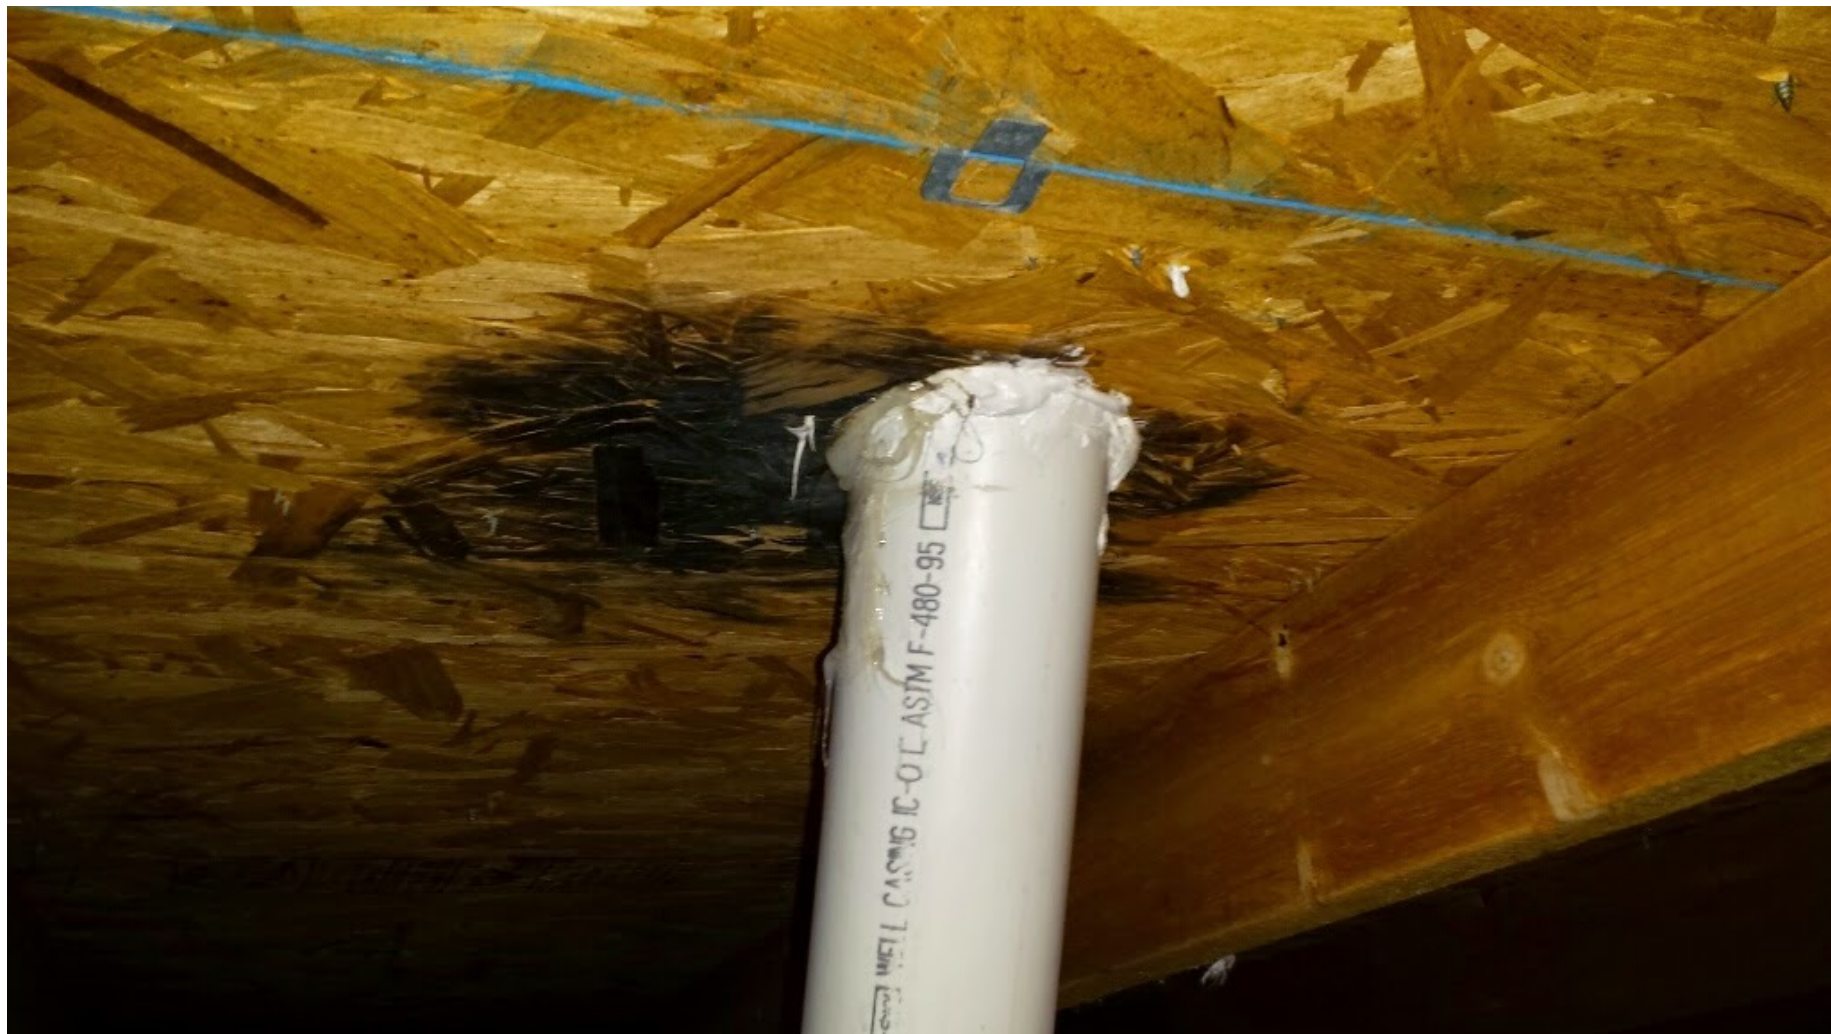
Roof Leak at Vent Pipe

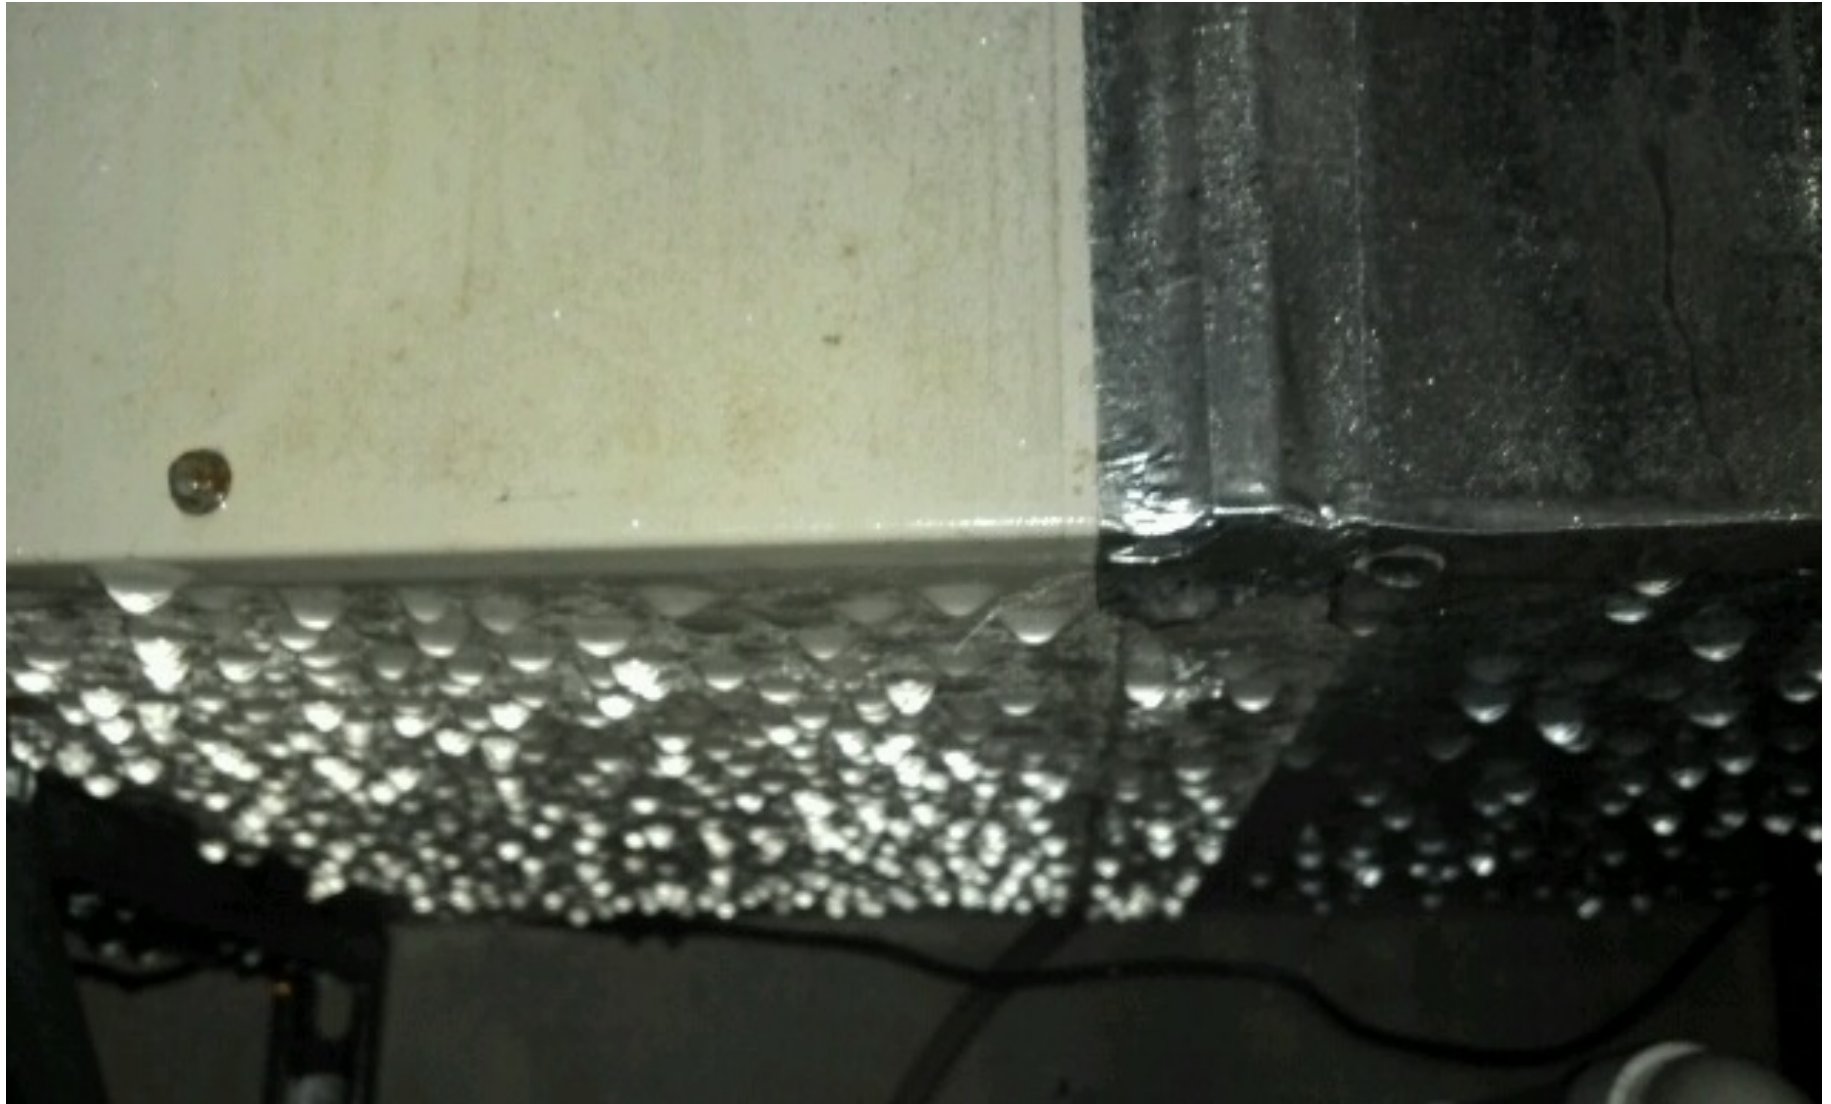
Condensation of Attic Air Handler

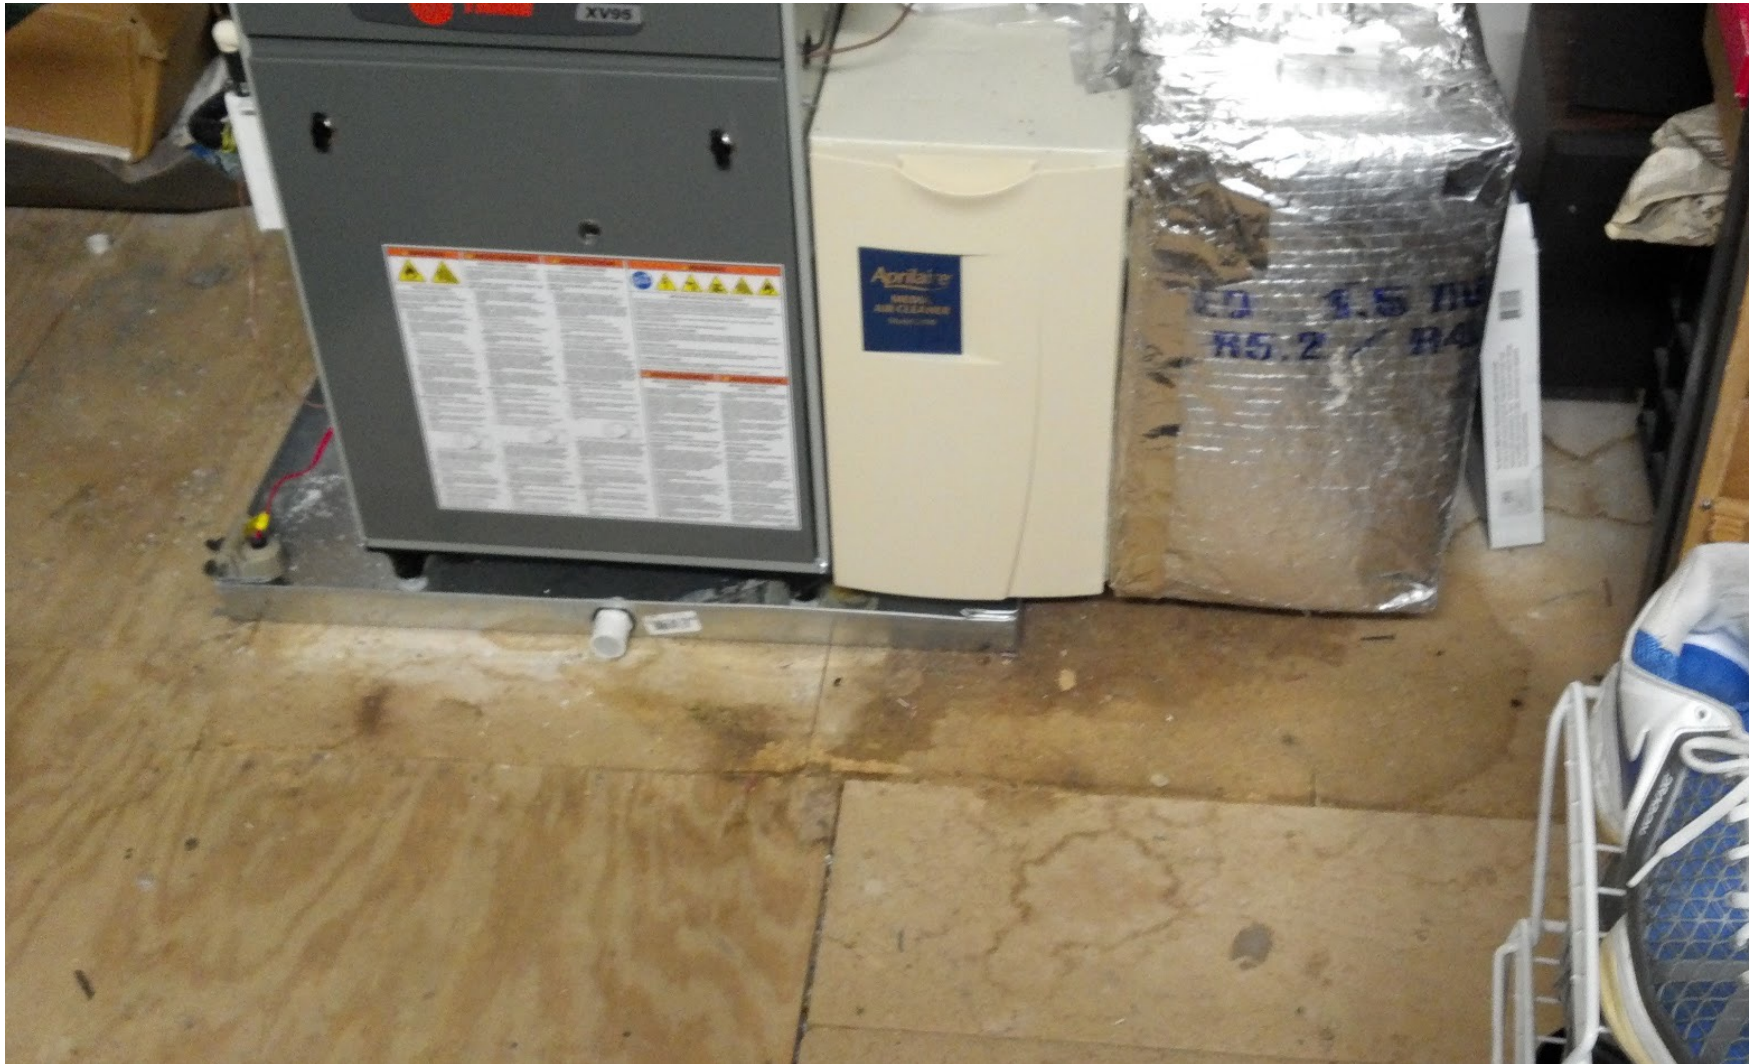
Leak in Ducting at Attic Unit

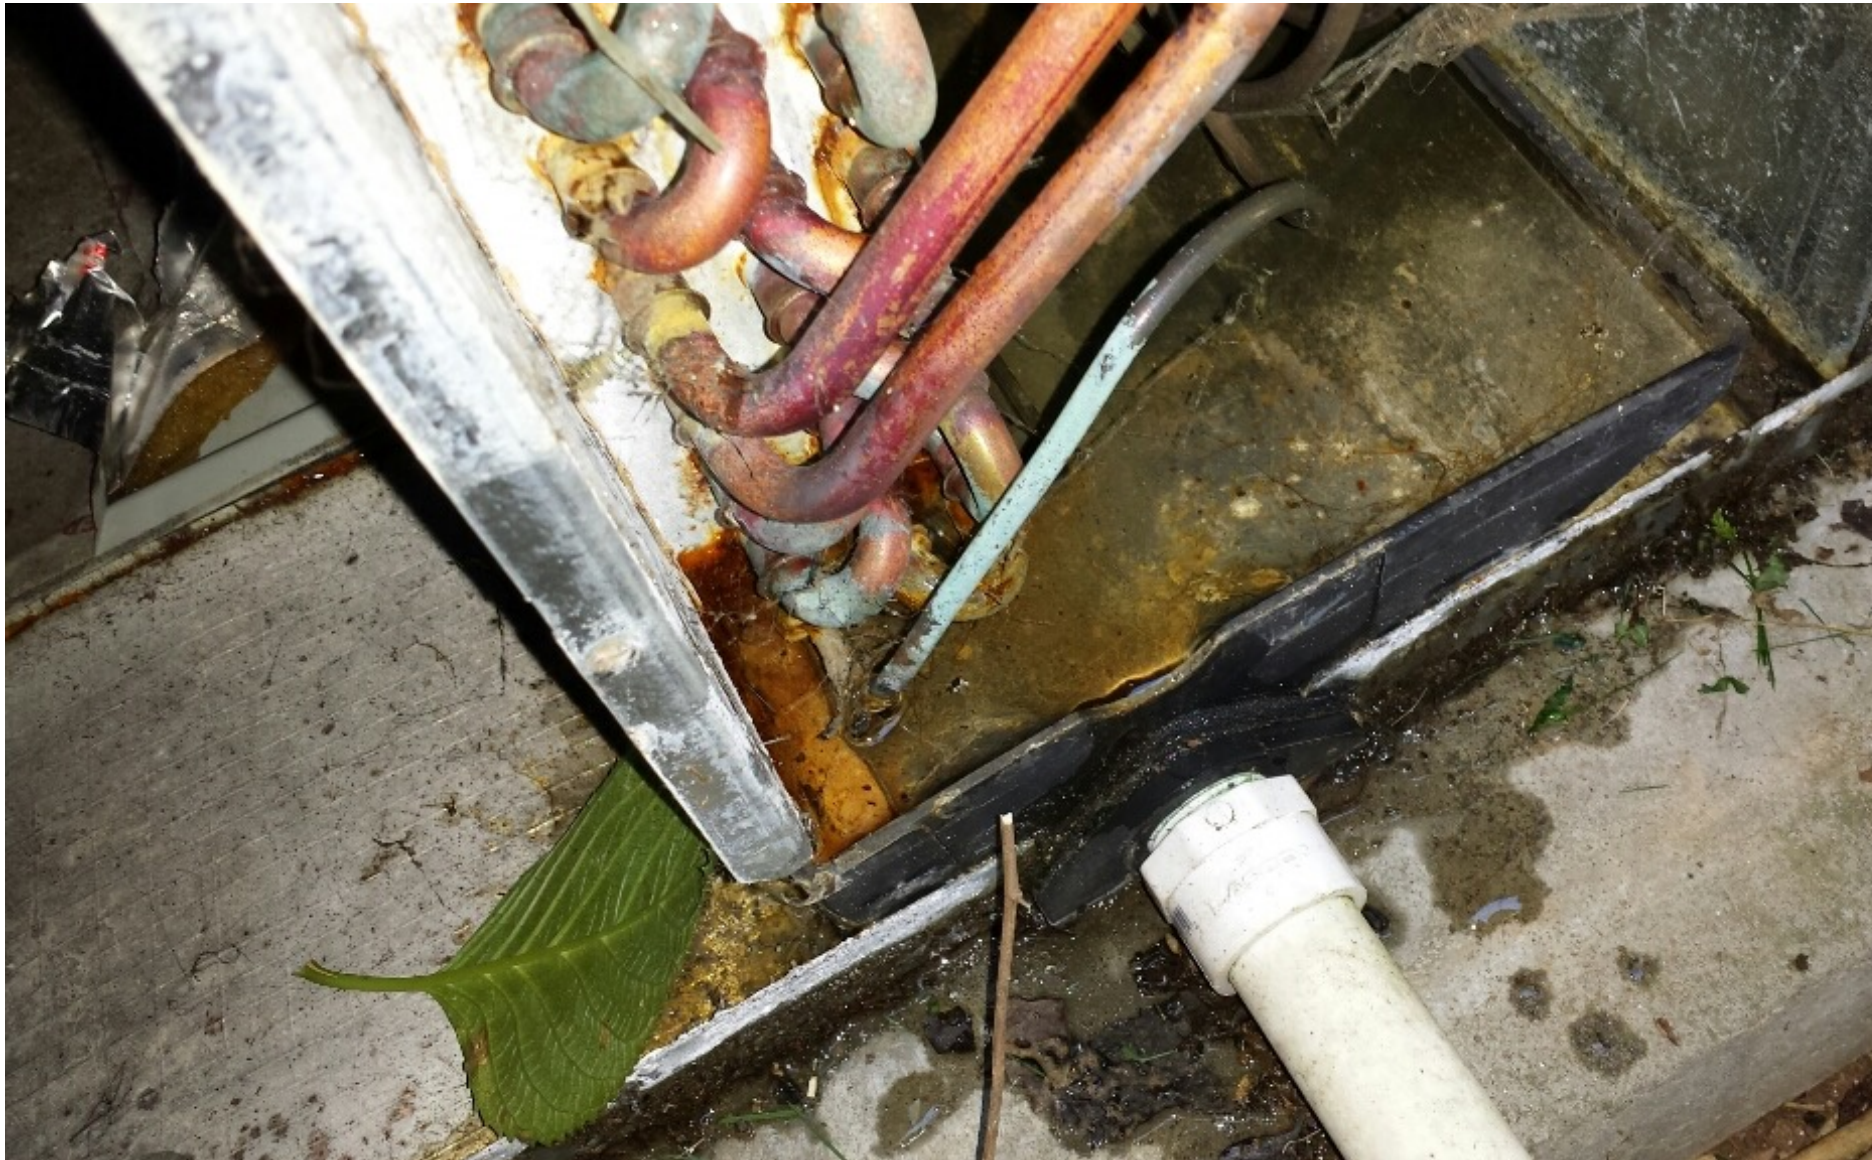
Standing Water in Air Handler

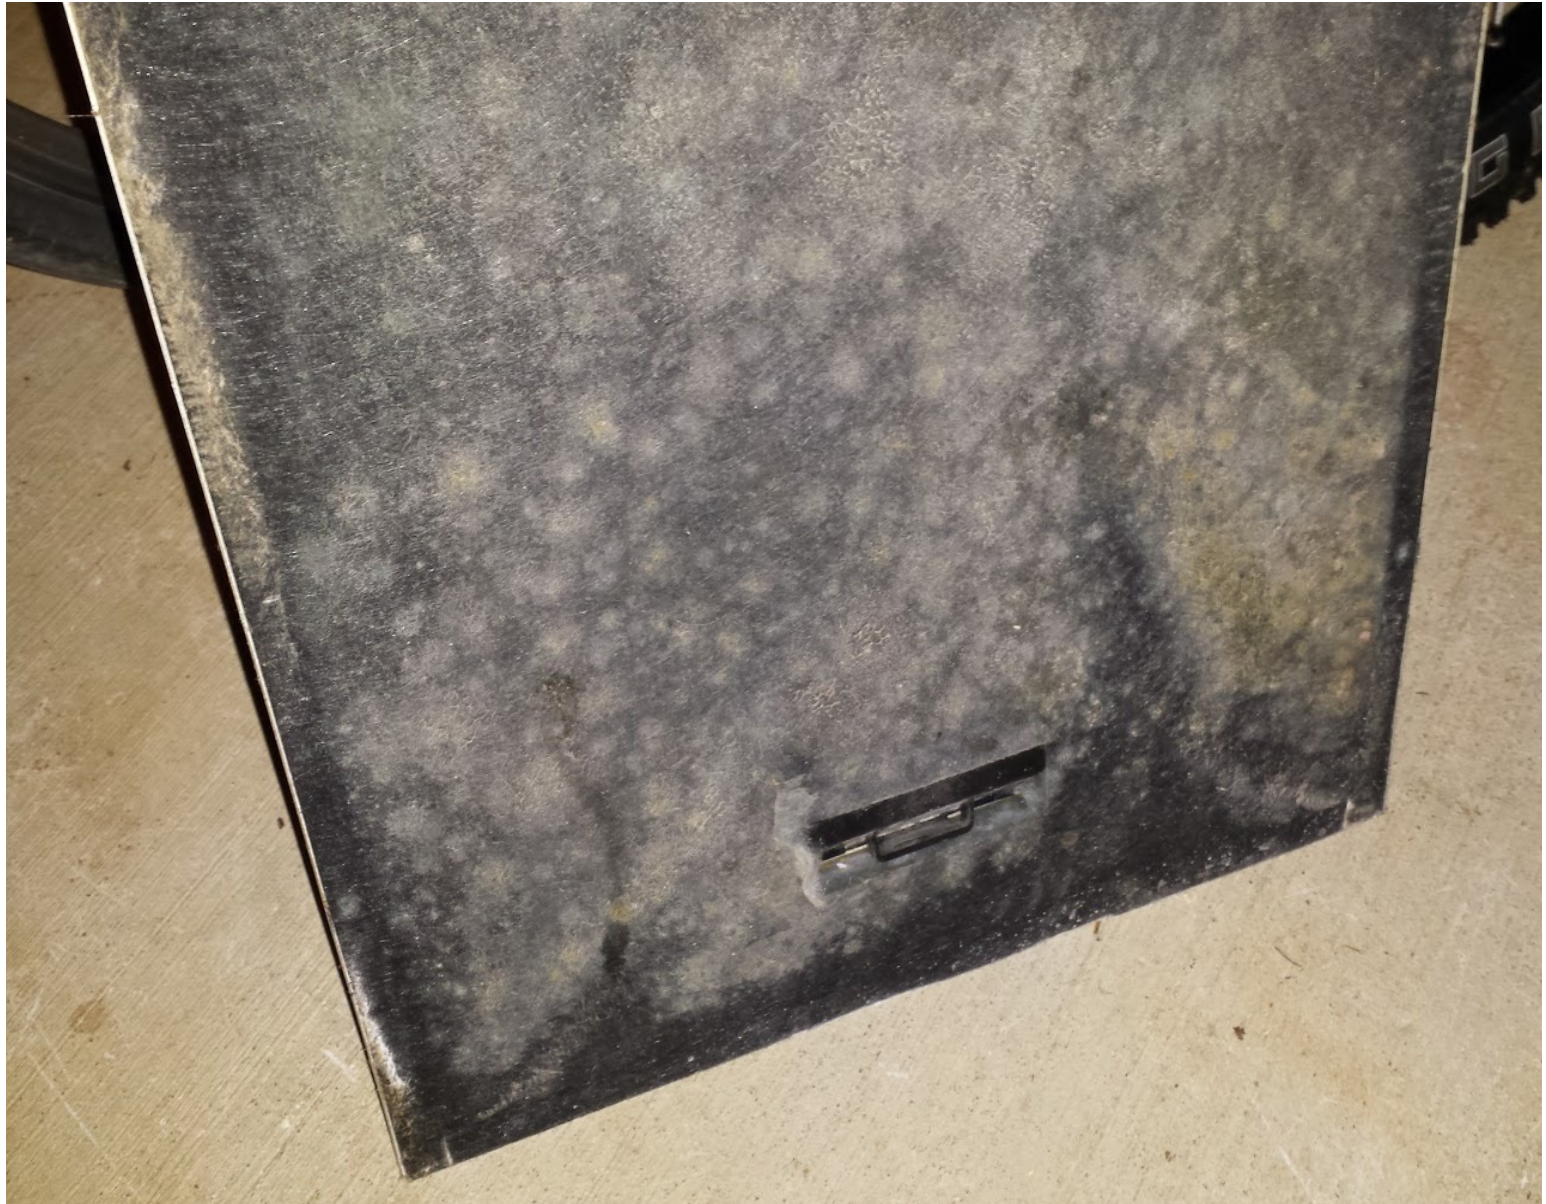
Air Handler Access Door

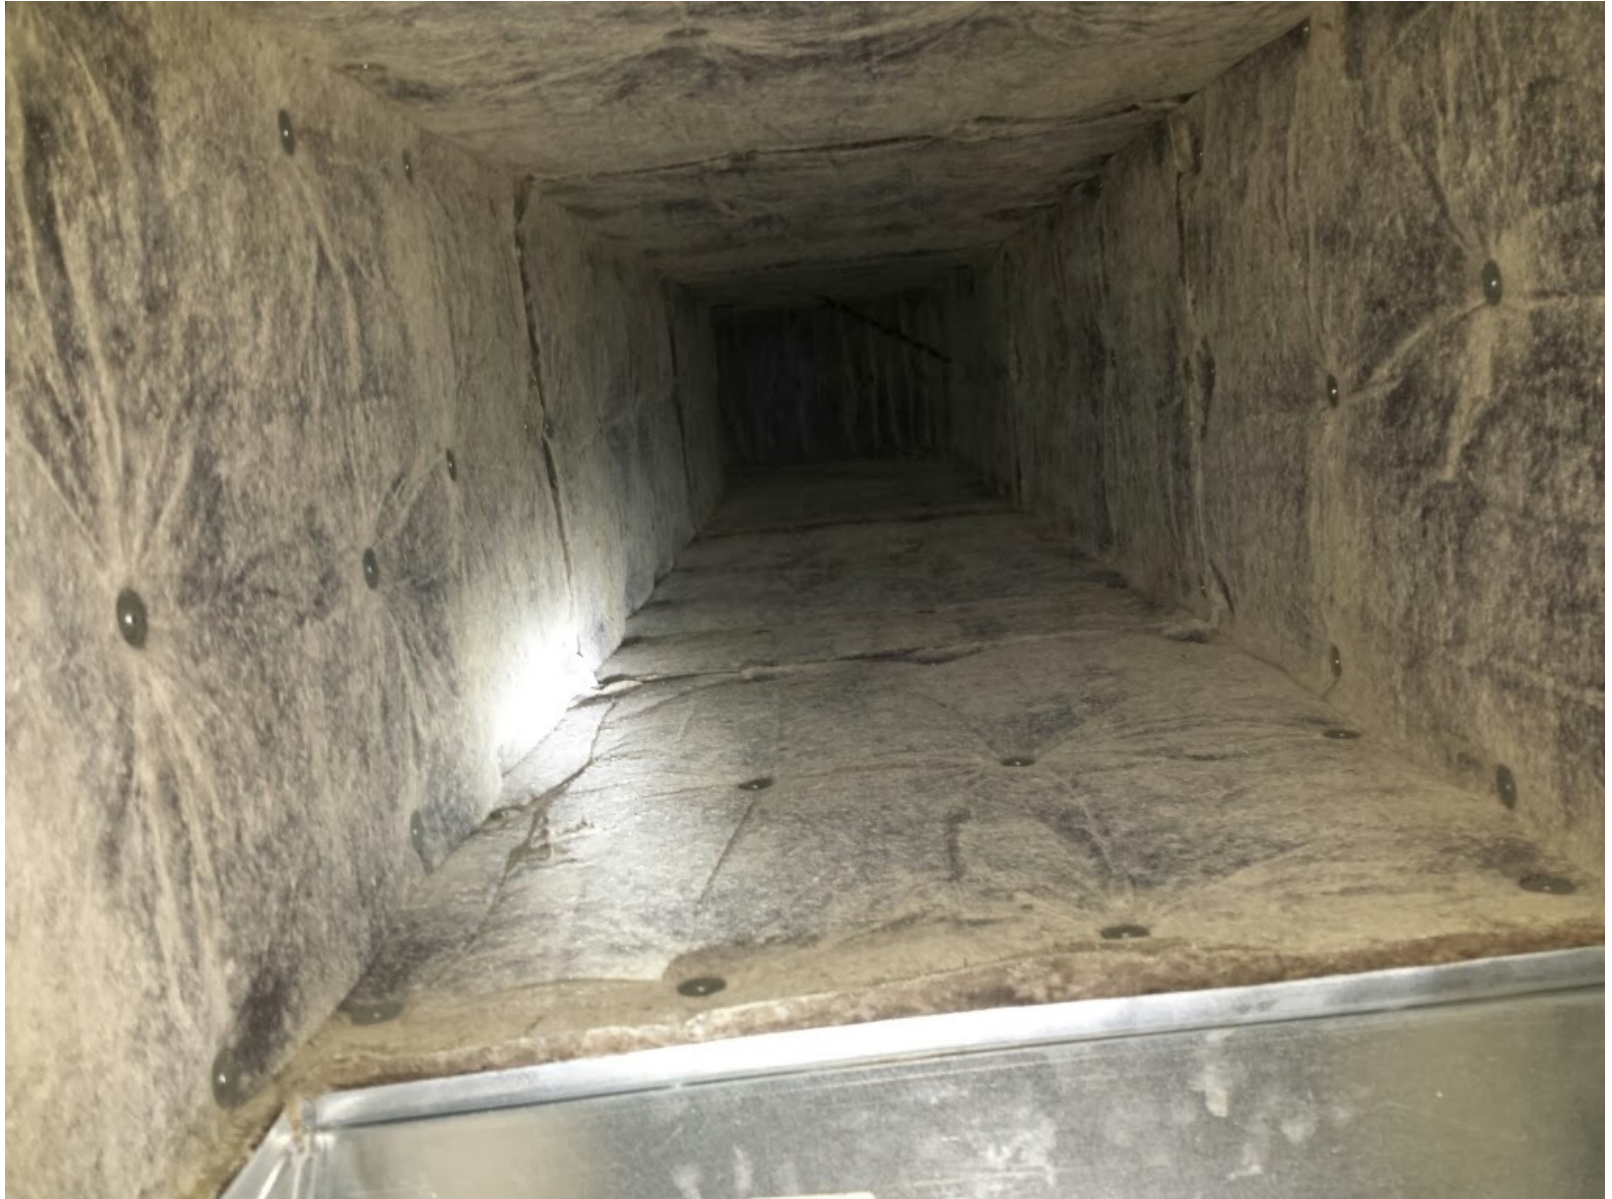
Commercial HVAC Duct Liner

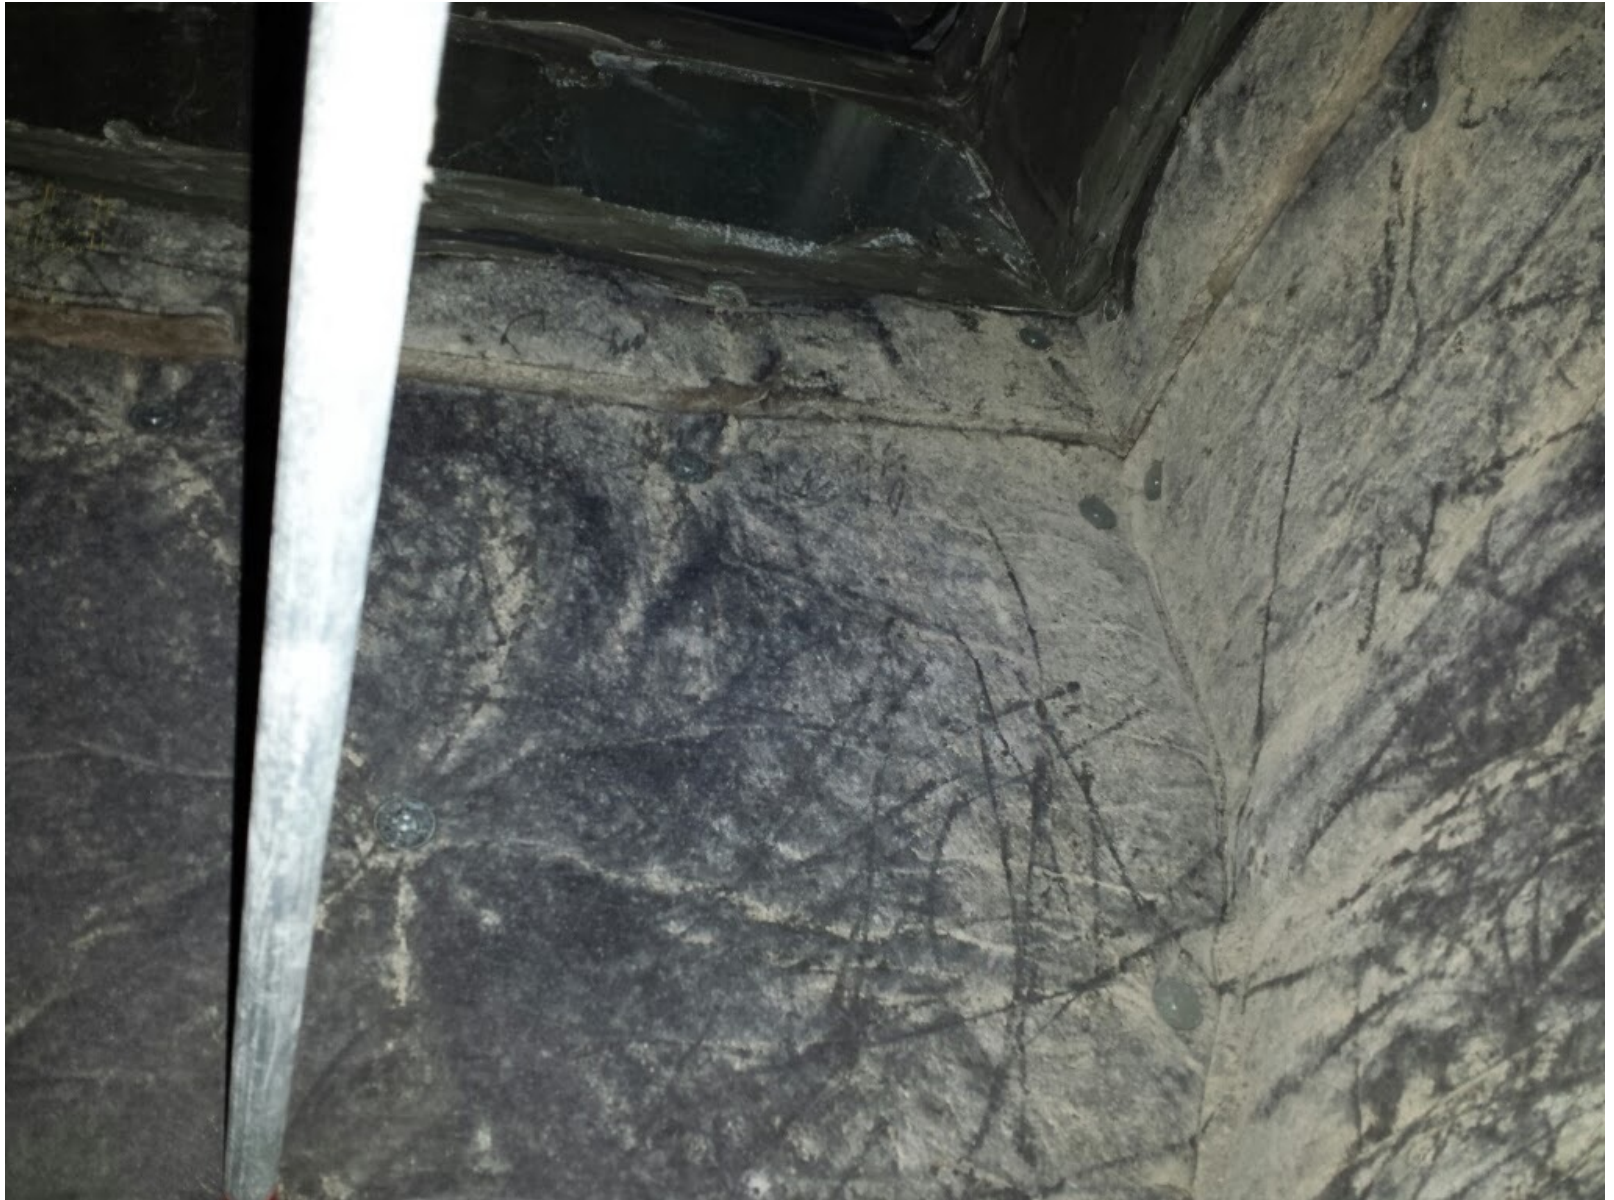
Duct Liner- Post Duct Cleaning

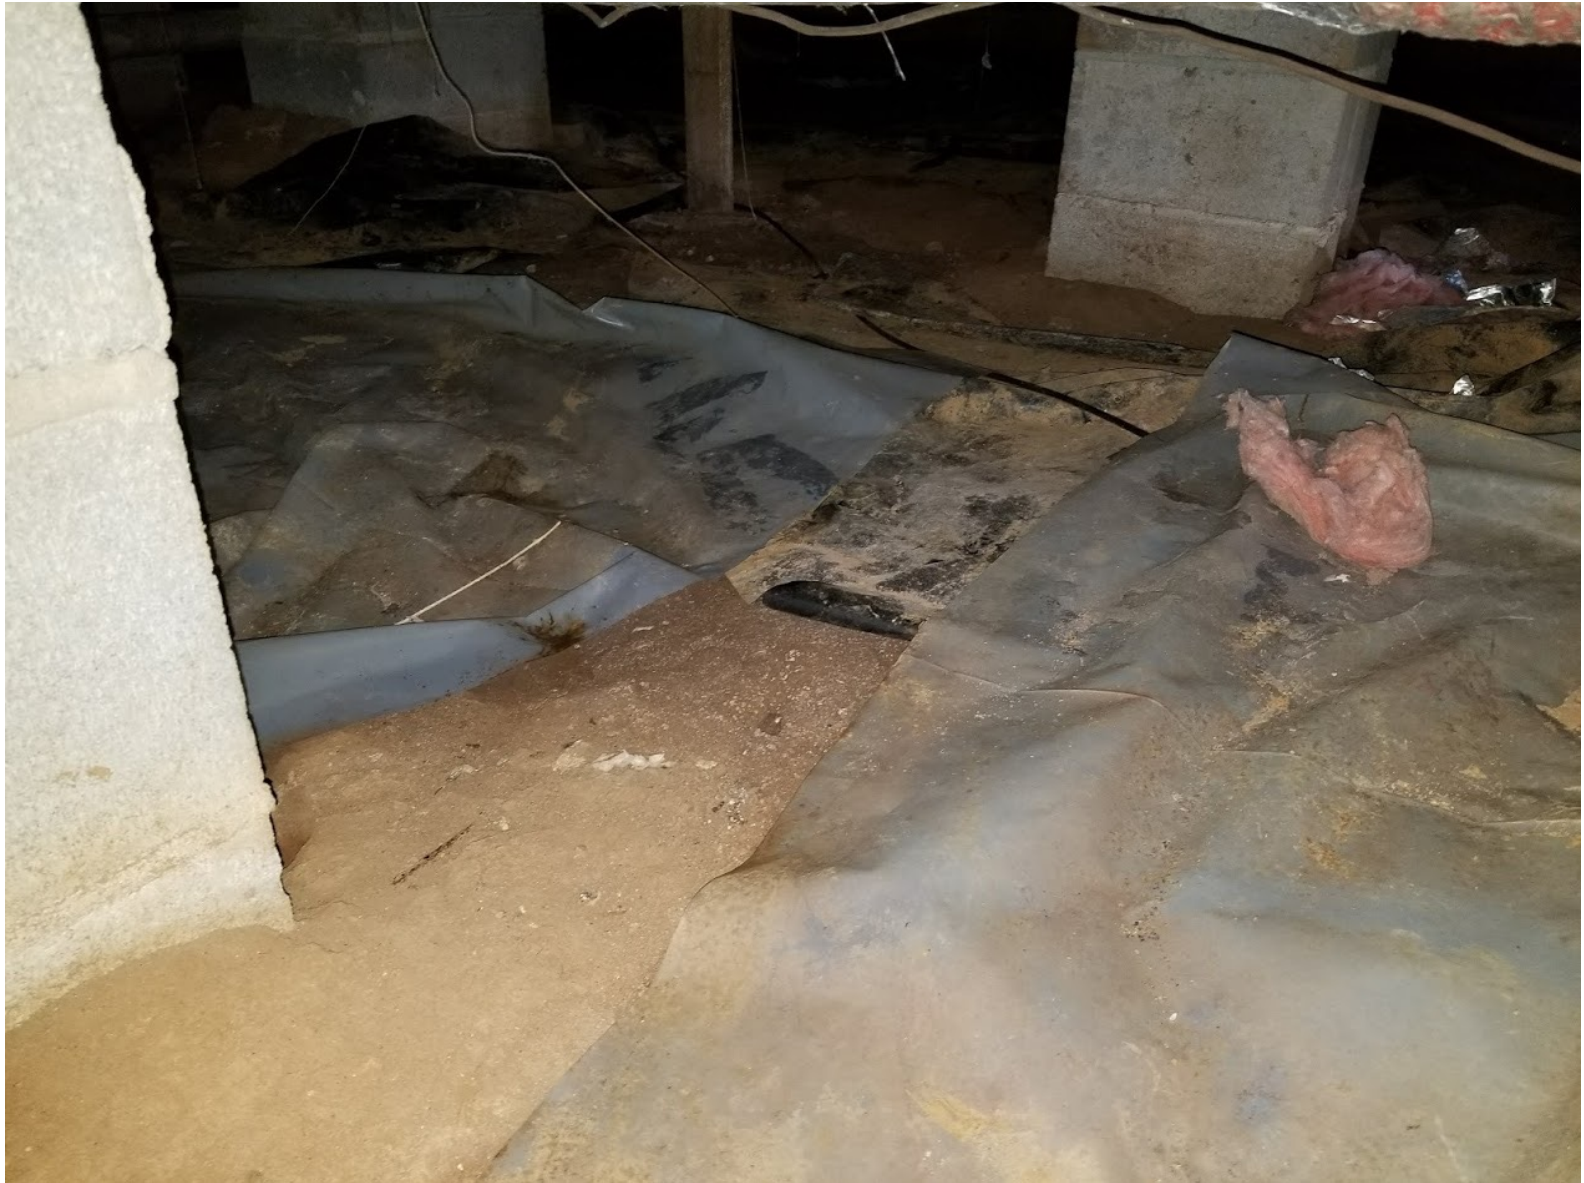
Vapor Barrier Not Intact

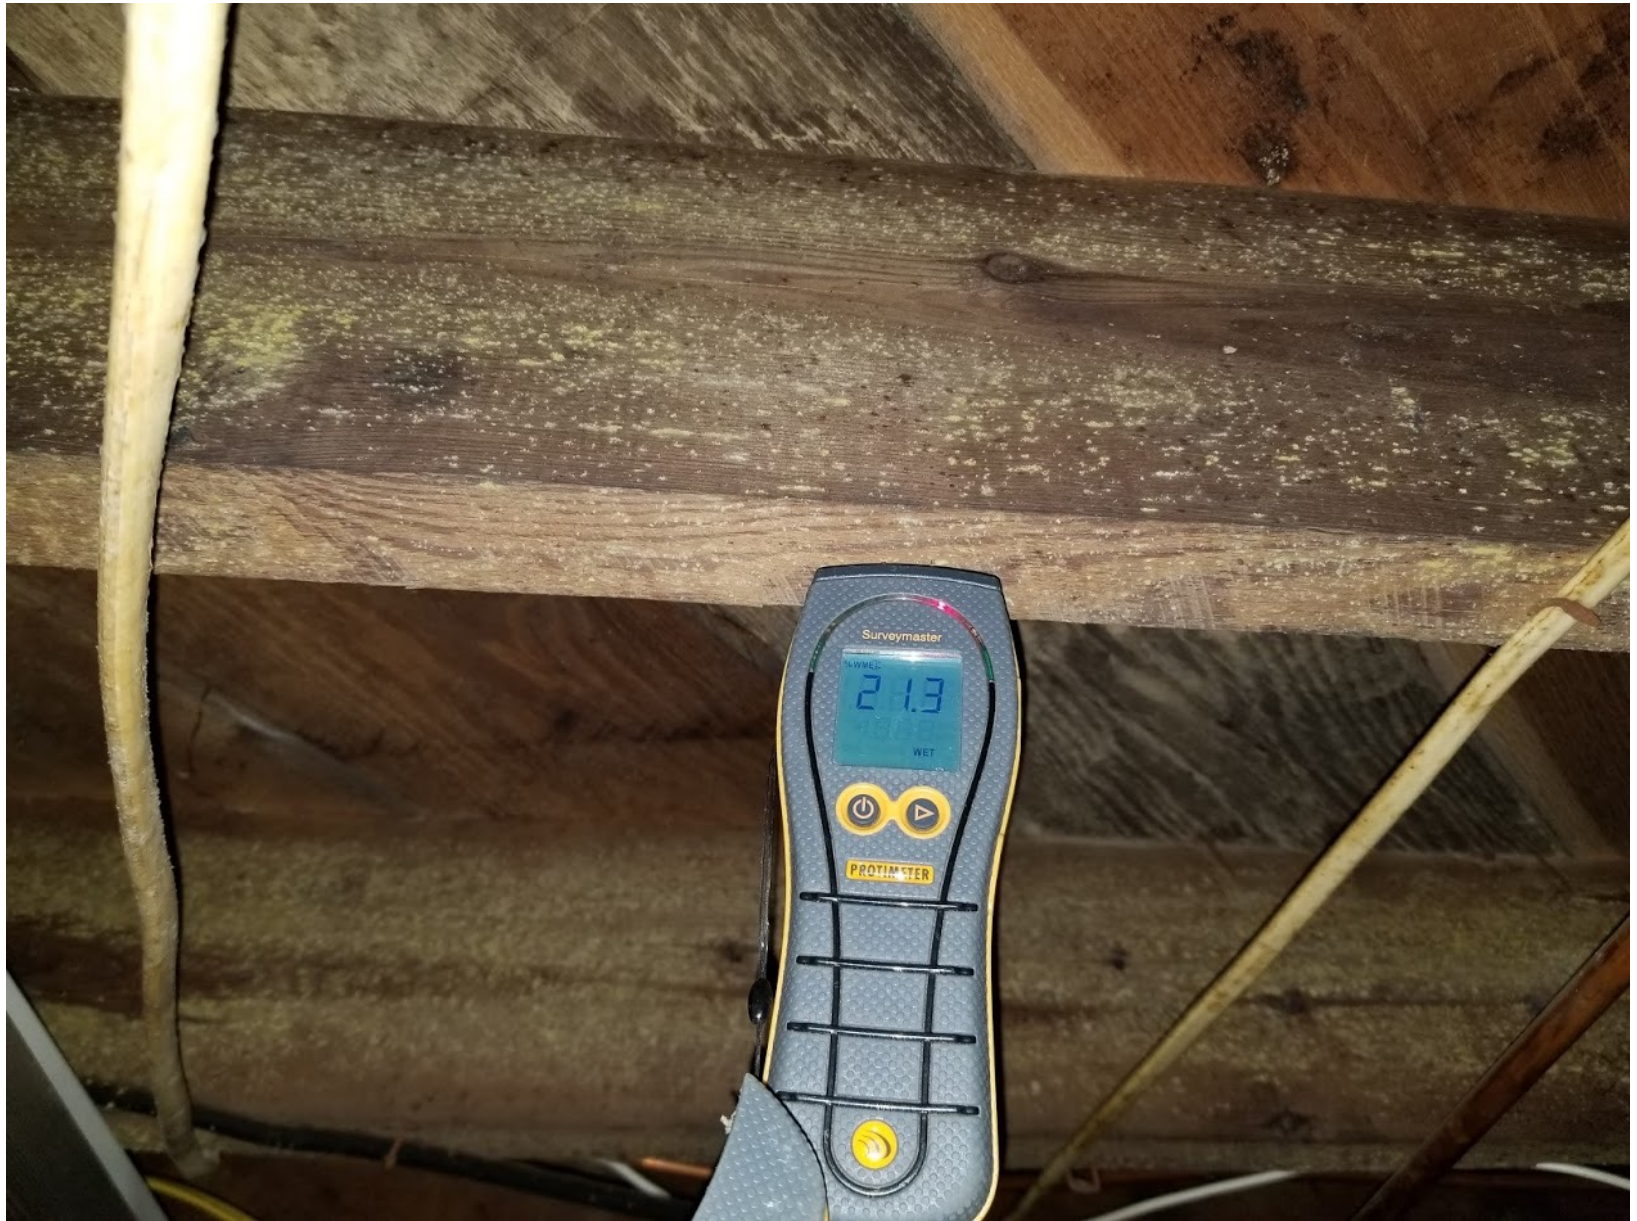
Elevated Moisture in Joist

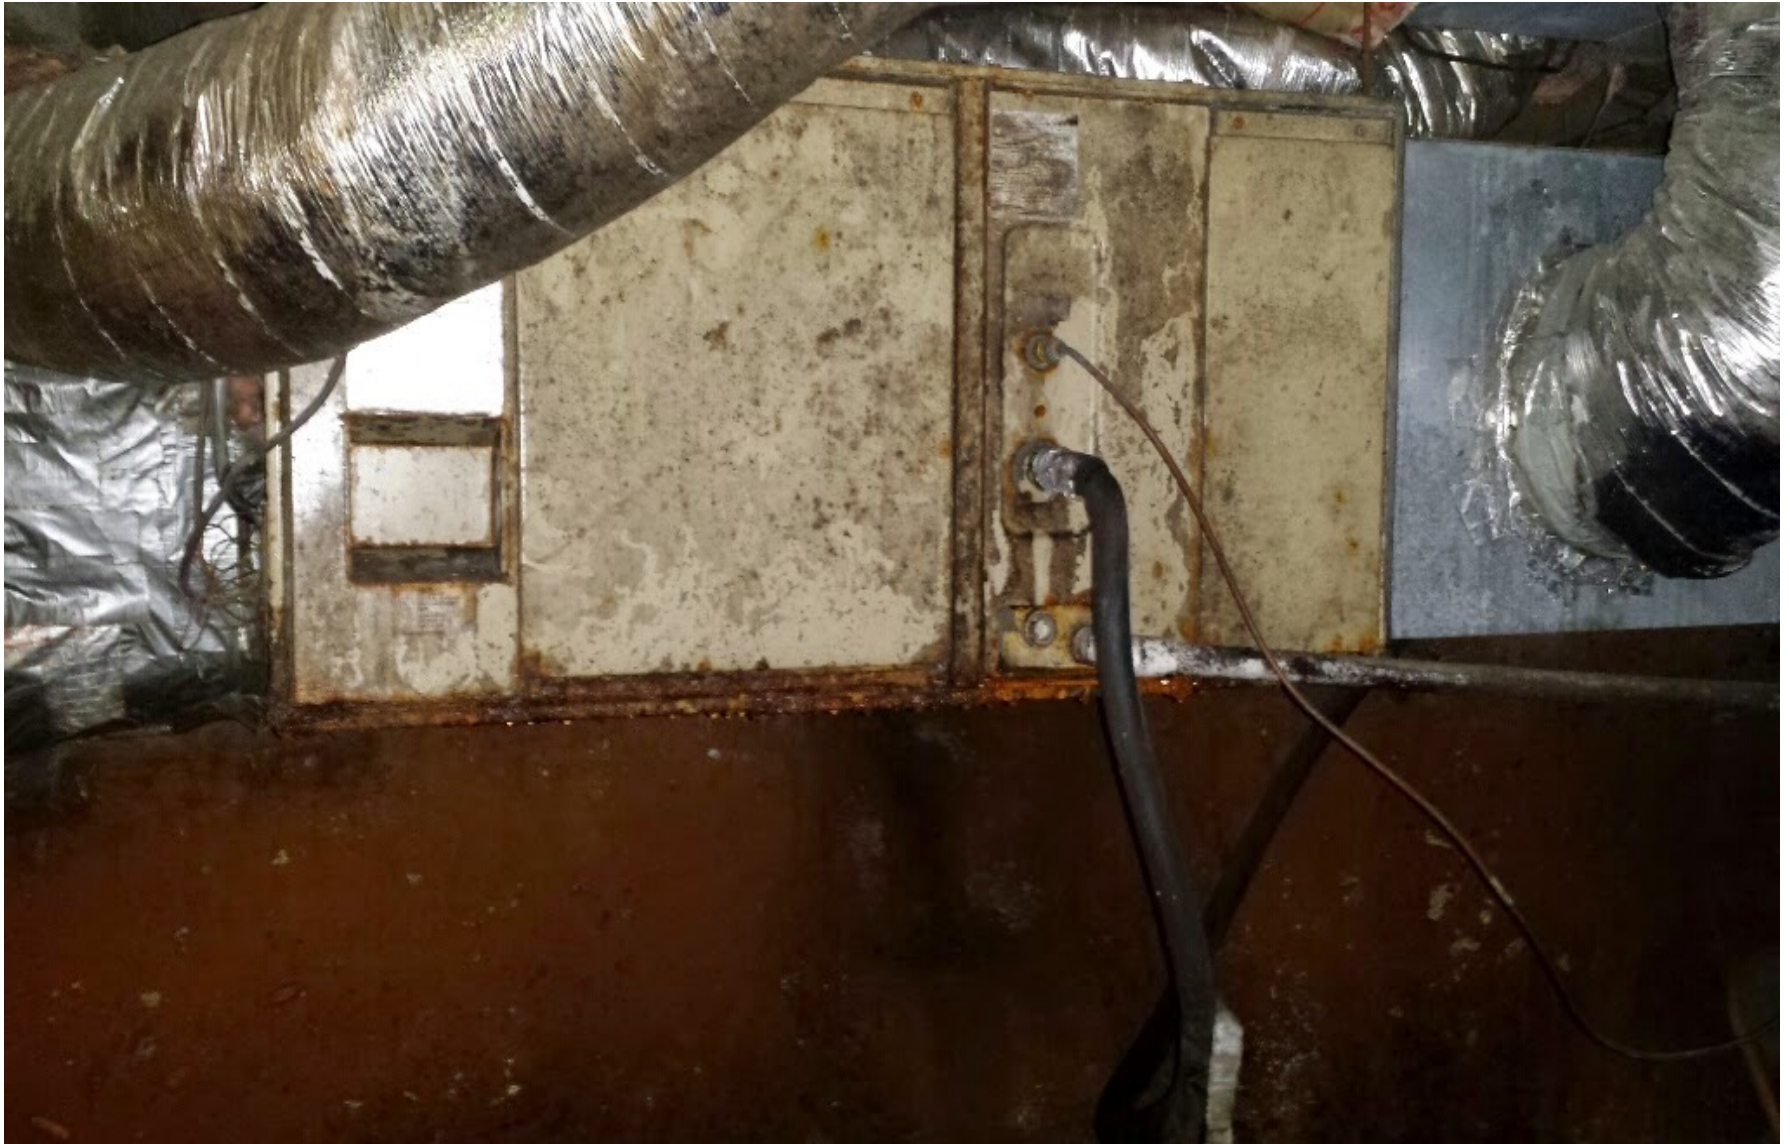
Crawlspace Air Handler

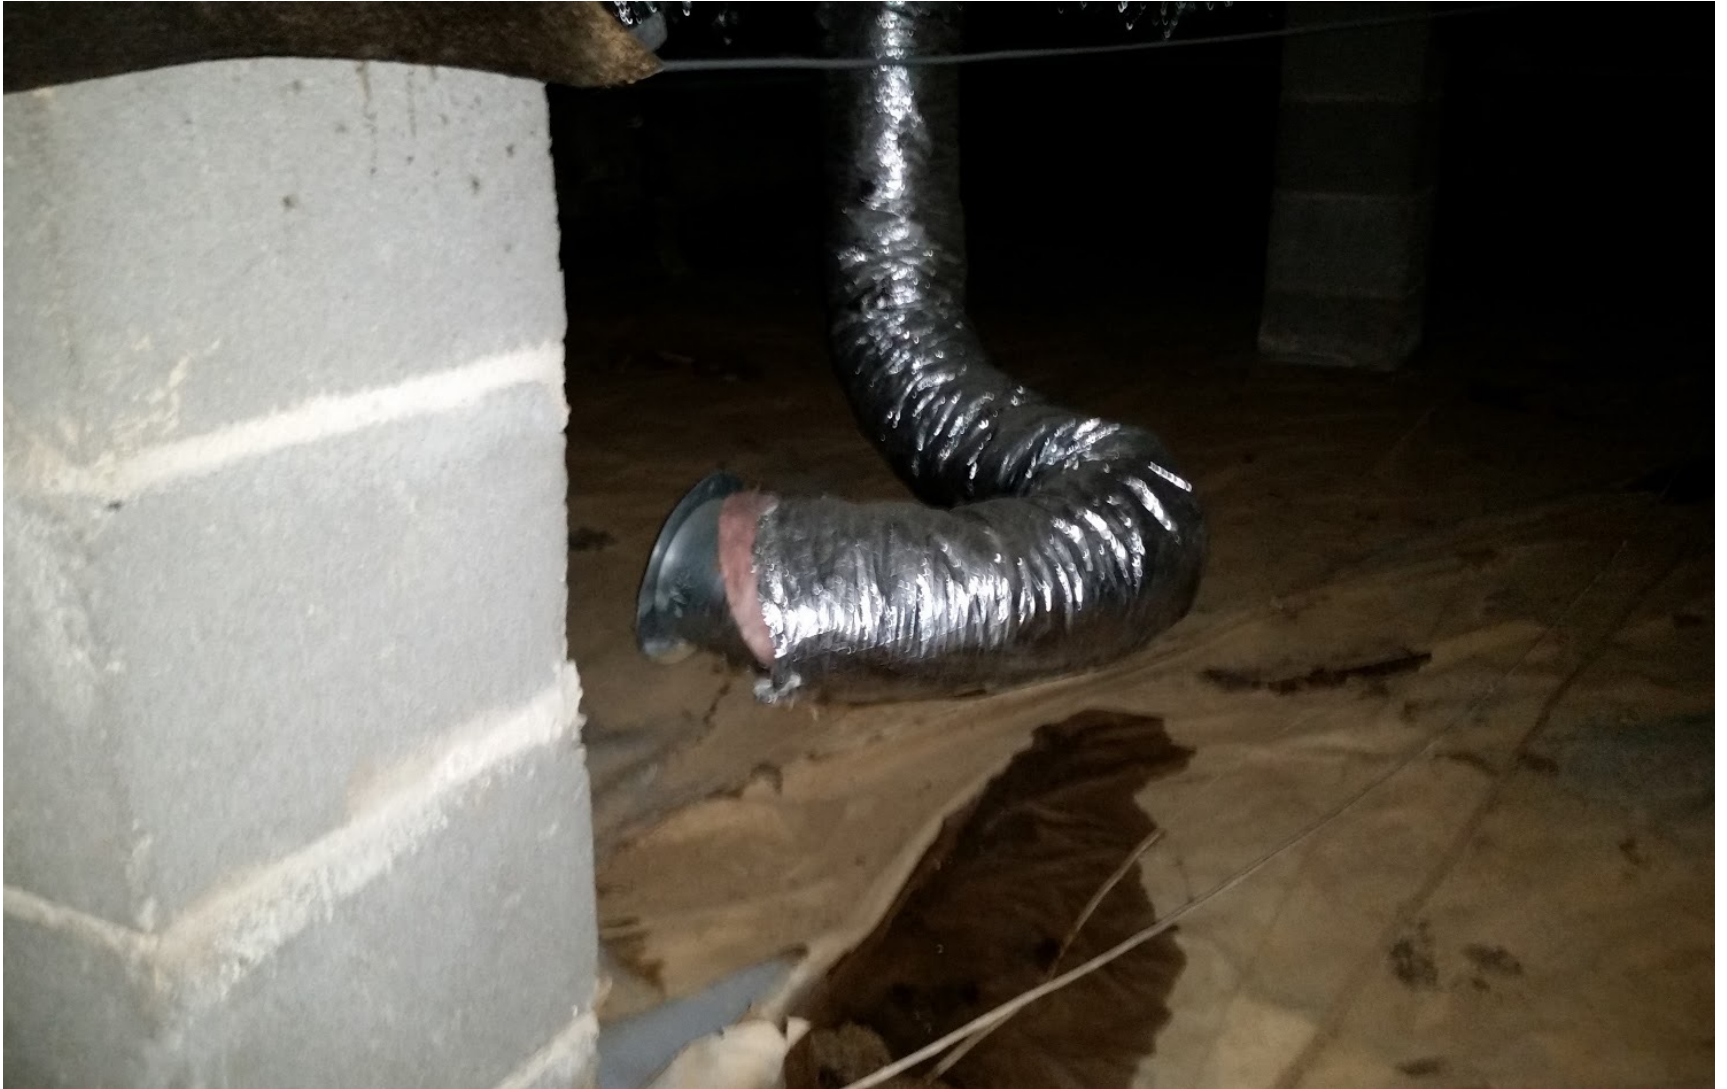
Disconnected HVAC Duct

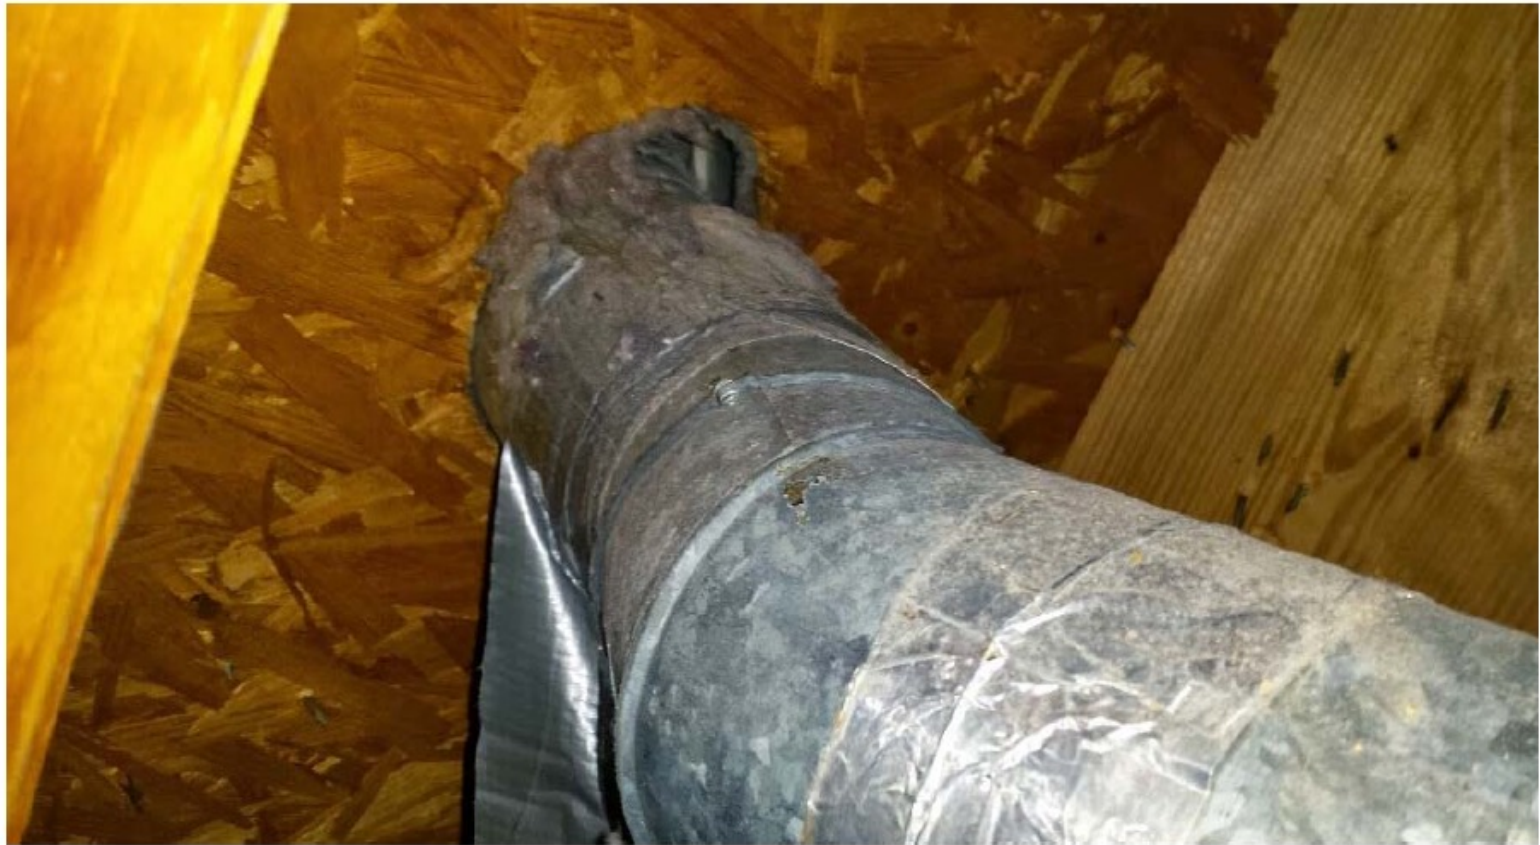
Figure 6 is documentation of a leaking dryer exhaust duct located in the attic of the home. Introduction of humid air into an attic may contribute to elevated humidity and associated molds.

- Inspection of the home's attic found a dryer exhaust duct line to be leaking air into the attic during operation of the clothes dryer. Introduction of humid air into an attic or crawlspace is not advised due to the potential for contributing to humidity elevation and humidity associated mold growth. (Reference: **Figure 6**)
