Introduction to Residential Mold Assessment

Assured Bio Labs, LLC

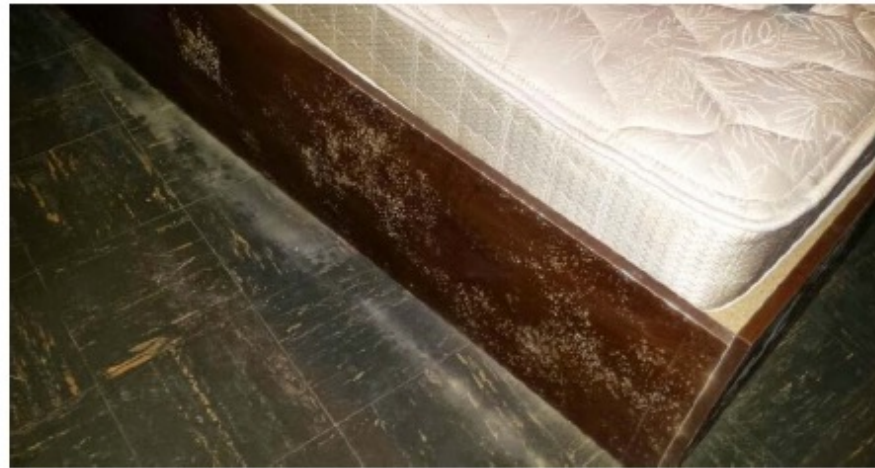
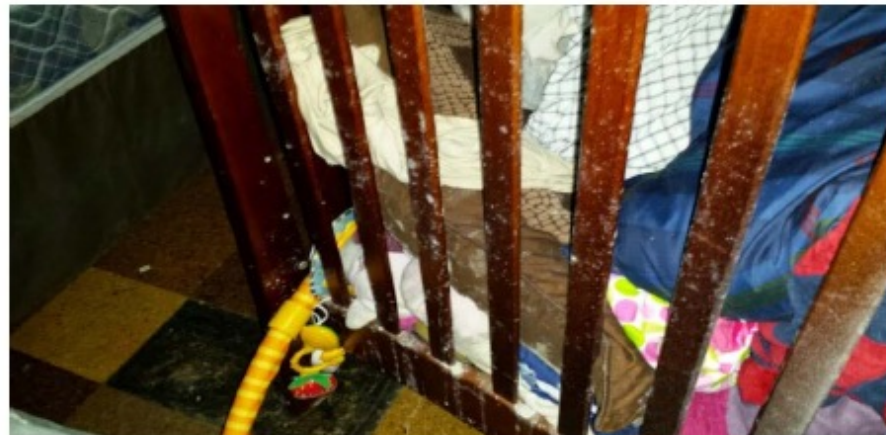
Figure 1

Figures 1-4 document examples of suspected fungal growth found on various items in the basement level of the home. Direct exam analysis of a surface swab sample collected from suspected growth on contents in the blue corner bedroom indicated the presence of *Penicillium/Aspergillus*-like molds. (Assured Bio Direct Exam Report- Sample #8)

- Visual inspection of the basement level found multiple surfaces exhibiting suspected fungal growth. Direct exam analysis of a surface swab sample collected from contents in the blue corner bedroom on the basement level verified the presence of *Penicillium/Aspergillus*-like molds. (Reference: Figures 1-4/ Assured Bio Direct Exam Report- Sample #8)

- Visual inspection of the basement level found multiple surfaces exhibiting suspected fungal growth. Direct exam analysis of a surface swab sample collected from contents in the blue corner bedroom on the basement level verified the presence of *Penicillium/Aspergillus*-like molds. (Reference: **Figures 1-4**/ Assured Bio Direct Exam Report- Sample 8)
