**Sample Number:** DI020309-1-2

**Sample ID:** Sample #2

**Results:** **Incongruent** The FTIR spectrum of the sample lacks one or more spectral characteristics and/or peaks identified in contaminated Chinese drywall reference materials.

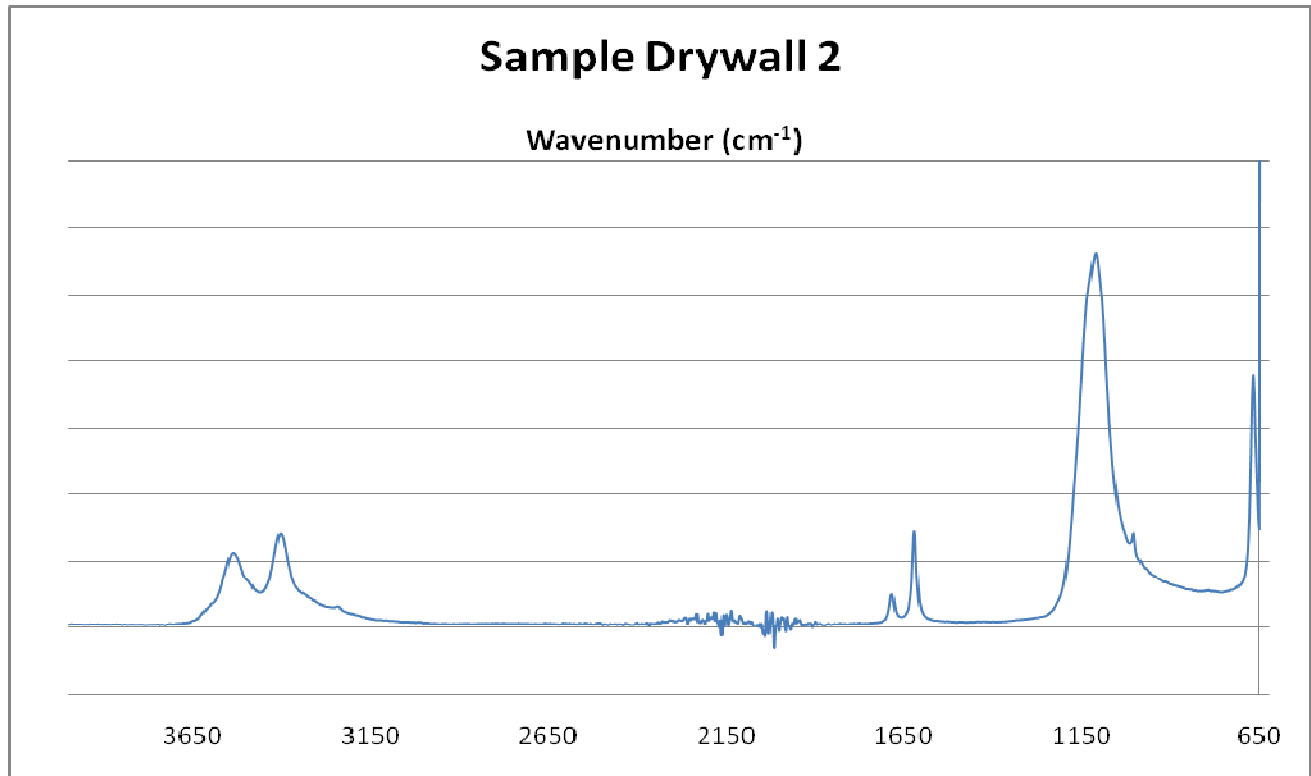
**Figure.** Spectral Fingerprint of sample. Each spectral fingerprint is generated from 34,010 data points. The data points are used to determine spectral congruency with known chinese drywall reference materials. Please note that the above figure is a condensed graphical representation of the averaged data scans and not intended for intersample comparisons.
